# RESERVE FUND STUDY REPORT

## **MACEWAN GARDENS II CONDOMINIUM CORPORATION 263 MACEWAN ROAD, EDMONTON, ALBERTA CONDOMINIUM PLAN No. 092 4818**

**DECEMBER 2013**

**WADE ENGINEERING LTD.**  
15359-117 Avenue, Edmonton, AB T5M 3X4

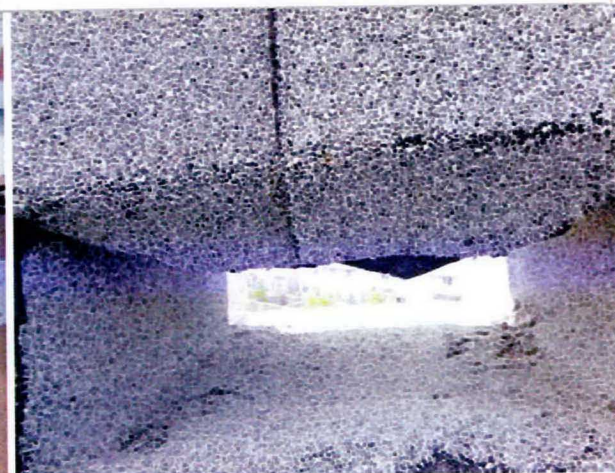
Incomplete detailing at overflow scupper drain

- **Roofing (Report – Pg. 7, Spreadsheets – Lines 1 to 3):** Properly detail overflow scupper drains.
- **Exterior Wall Cladding (Report – Pg. 11, Spreadsheets – Lines 7 to 12):** Seal all wall penetrations and repair deteriorating stucco. If staining worsens, further review cause of staining on the stucco and architectural block wall.

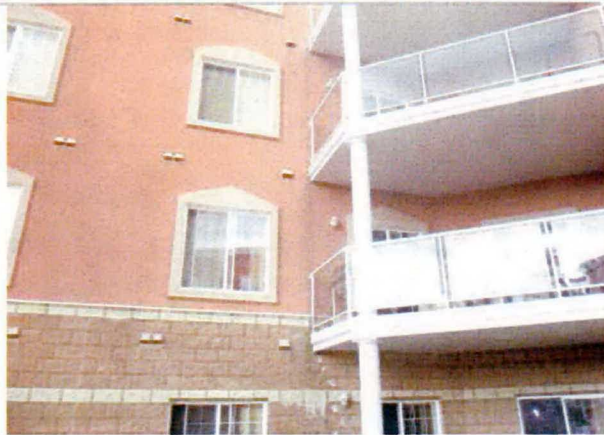
- Staining on the stucco and block veneer was noted below balcony to wall terminations at localized areas.
- The acrylic stucco finish is flaking off at one location.

**Staining on stucco below balcony to wall termination**

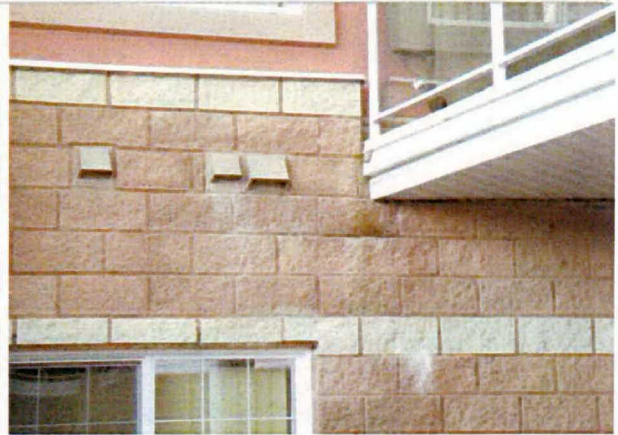
**Staining on surface of architectural block below balcony**

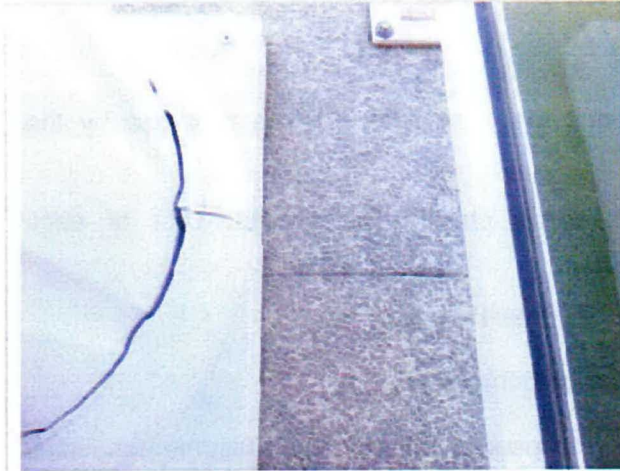
- A balcony membrane seam is not welded properly and should be repaired.
- Angle irons are corroding above localized window heads. If corrosion worsens further investigation for cause and appropriate repair should be conducted.

**Deteriorated membrane seam**

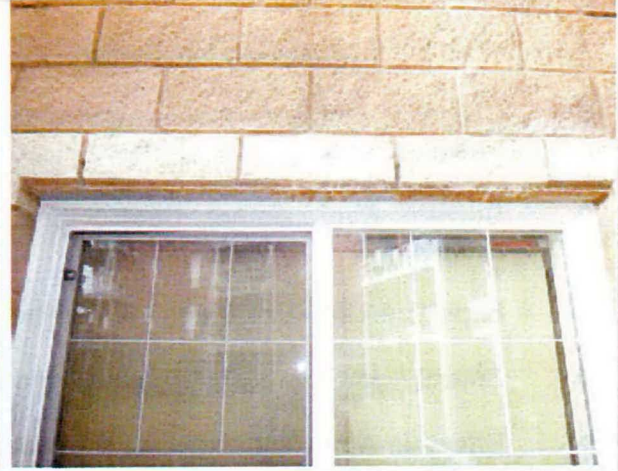
**Corrosion on angle iron above window head**
