RESERVE FUND STUDY REPORT

**MACEWAN GARDENS II
CONDOMINIUM CORPORATION
263 MACEWAN ROAD, EDMONTON, AB
CONDOMINIUM PLAN No. 092 4818**

**DECEMBER 2019
REPORT AMENDED (AUGUST 2021)**

**WADE ENGINEERING LTD.**
15359-117 AVENUE, EDMONTON, AB T5M 3X4

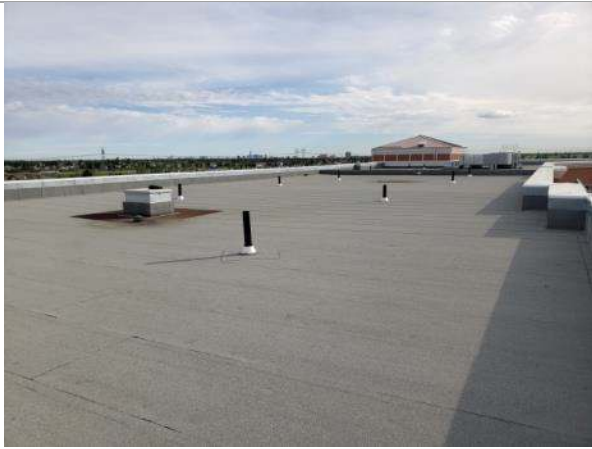
Photograph 1

Overview of SBS roof

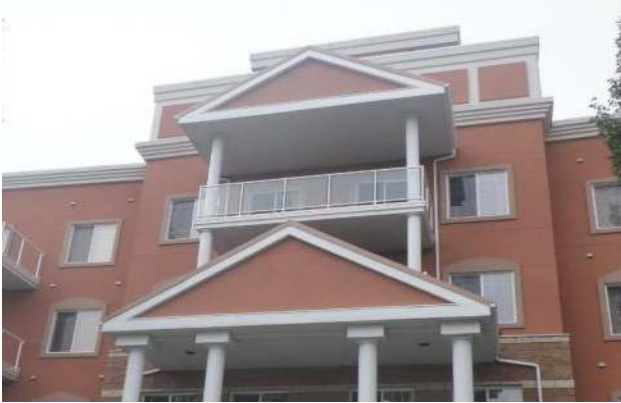
<p style="text-align: center;">Photograph 15</p>		<p>Prefinished metal fascia</p>		
<u>GOOD PRACTICE GUIDELINES:</u> <ul style="list-style-type: none"> ❖ Inspect annually for loose or damaged sections and repair as necessary.

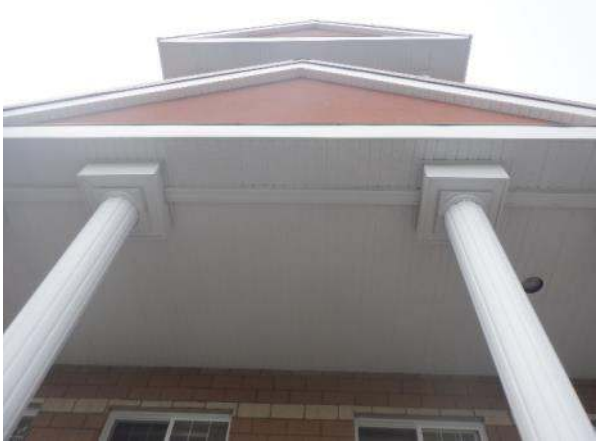
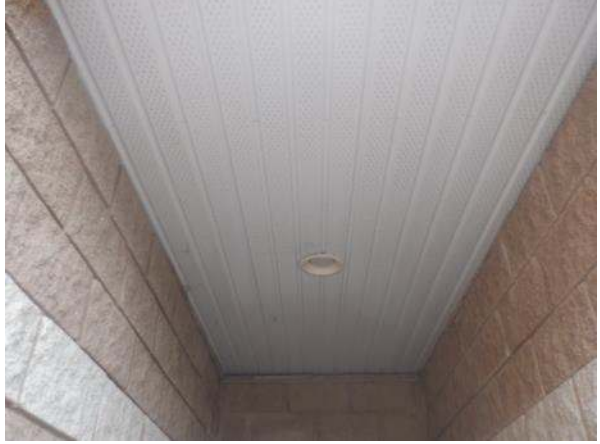
Photograph 16			Photograph 17		
Perforated prefinished metal soffit					
<u>GOOD PRACTICE GUIDELINES:</u>					
❖ Inspect soffits annually for deficiencies and schedule appropriate investigations or repairs.

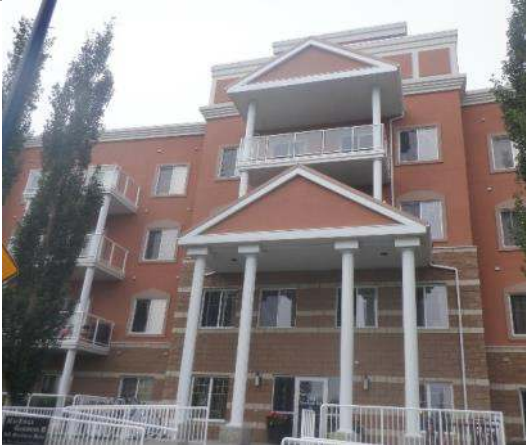
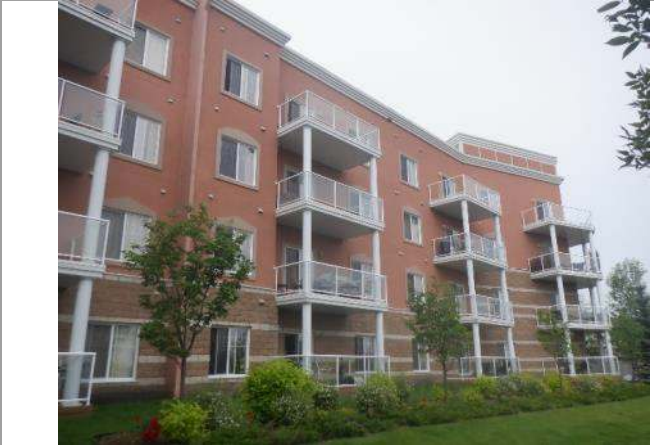
Photograph 18			Photograph 19		
Overview of building elevations

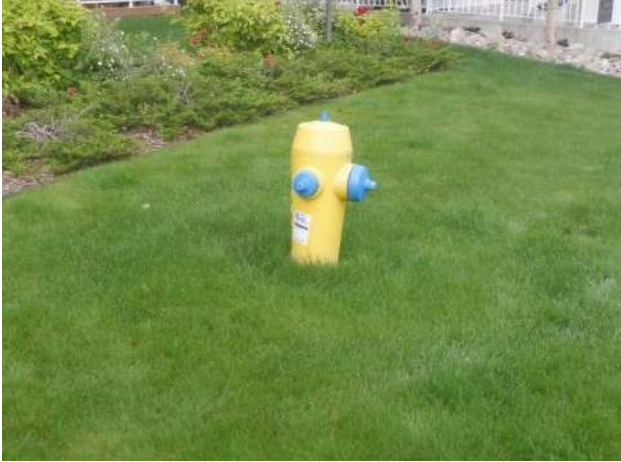
<p>Painted fire hydrant</p>		
<p>Photograph 76</p>				
<u>GOOD PRACTICE GUIDELINES:</u>				
<ul style="list-style-type: none"> ❖ Paint fire hydrant approximately every 10 years or as required with a rust inhibitive paint. ❖ Fire department regulations require annual inspection of fire hydrants to ensure their integrity is maintained for use in the event of an emergency.

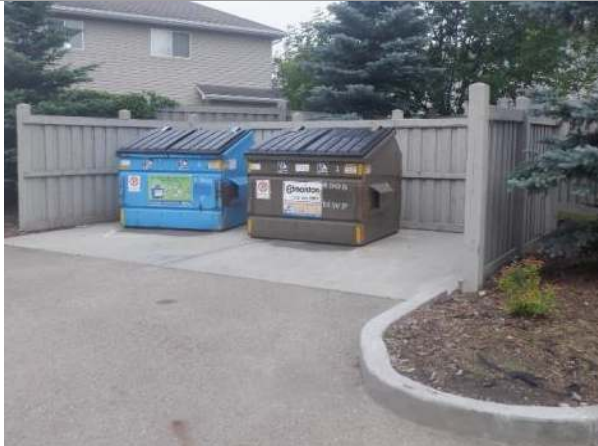
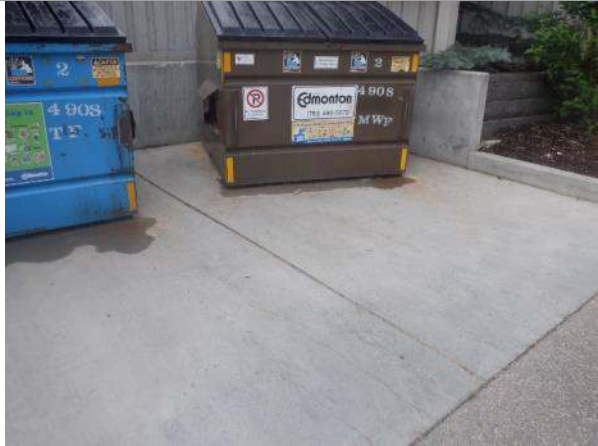
Photograph 77			Photograph 78		
Overview of garbage areas - wood fencing and poured concrete pads					
GOOD PRACTICE GUIDELINES:					
<ul style="list-style-type: none"> ❖ Do not use salt for de-icing, as it can cause spalling and premature deterioration of concrete. ❖ Paint fencing approximately every 7 years or as required to protect the wood from the elements.

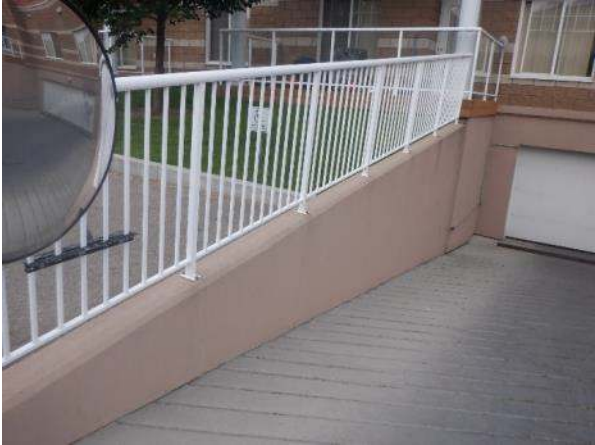
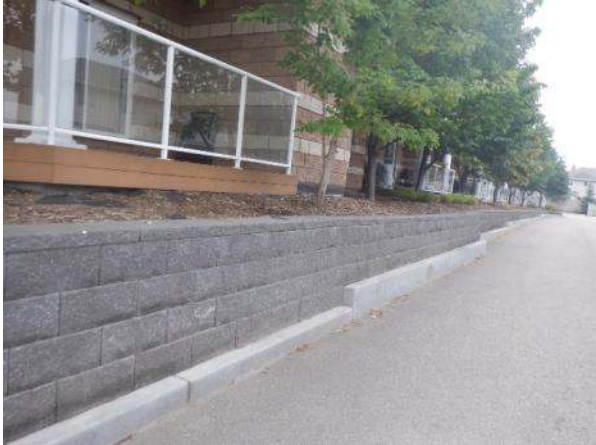
Photograph 93			Photograph 94		
Poured concrete retaining wall at parkade ramp			Allan block retaining wall		
GOOD PRACTICE GUIDELINES:					
❖ Inspect Allan block/retaining walls for movement. Complete repairs if safety or aesthetics are a concern.

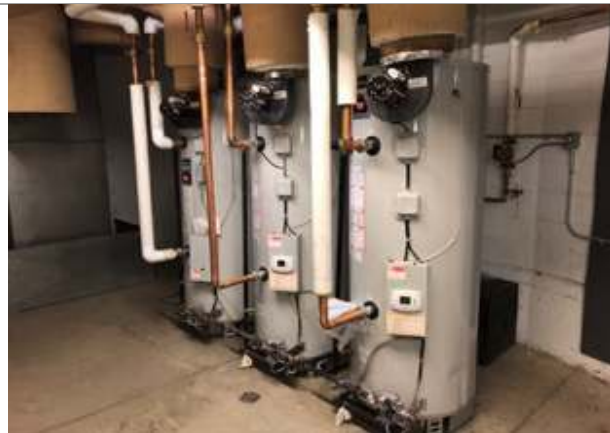
Photograph 99
Hot water tanks

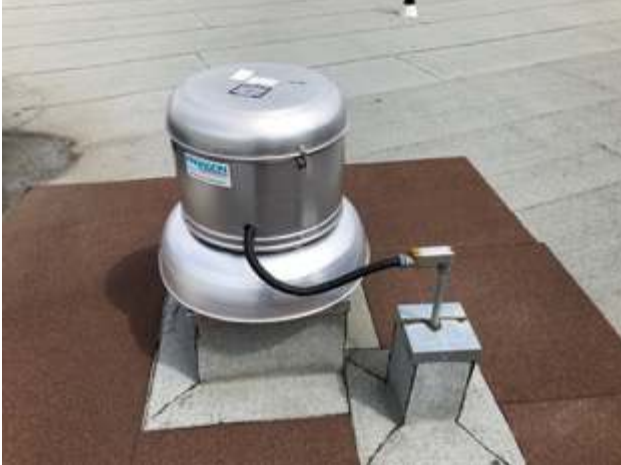
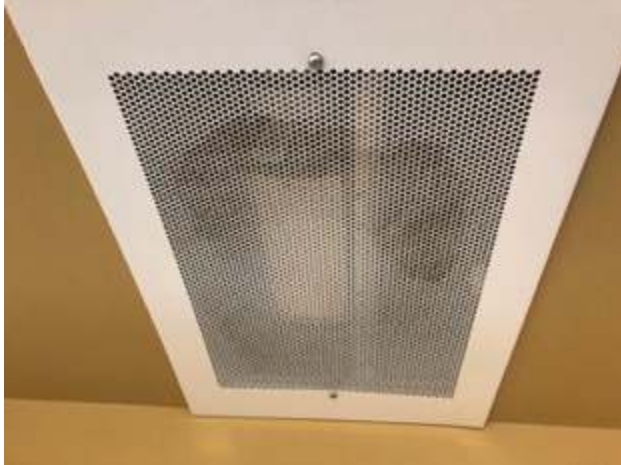
Photograph 109 Roof top exhaust fan			Photograph 110 Ceiling exhaust fan		
GOOD PRACTICE GUIDELINES:					
<ul style="list-style-type: none"> ❖ Inspect fan wheel periodically and clean as required.

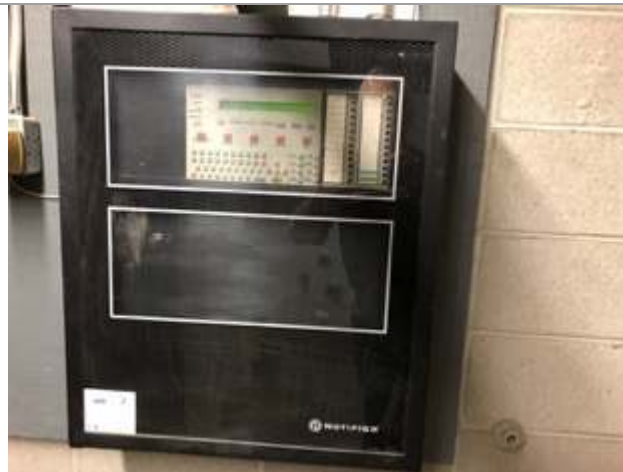
Photograph 111

Main fire alarm panel

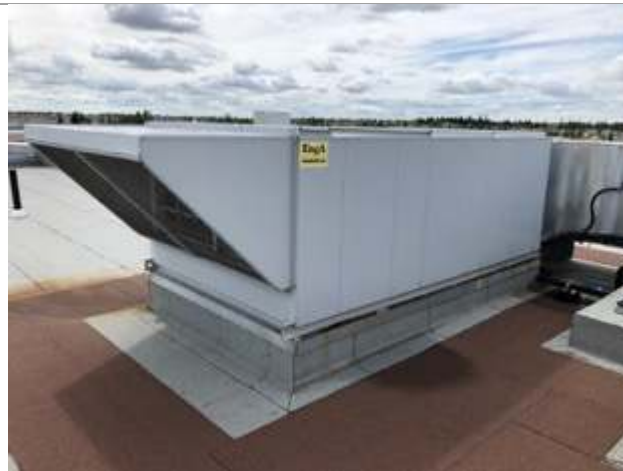
Photograph 116
Make-Up air unit

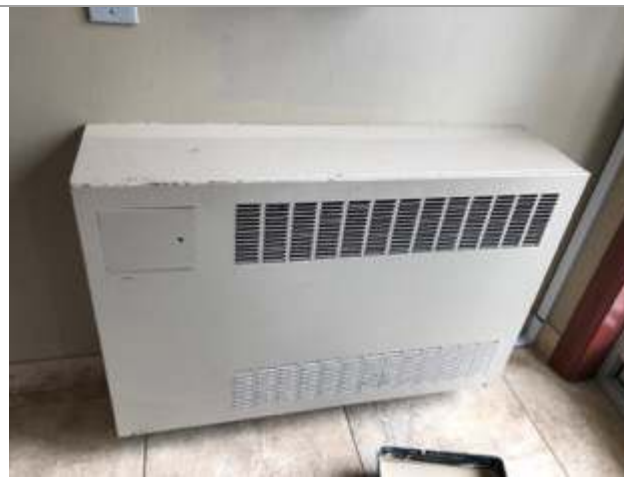
Photograph 142

Entrance cabinet heater

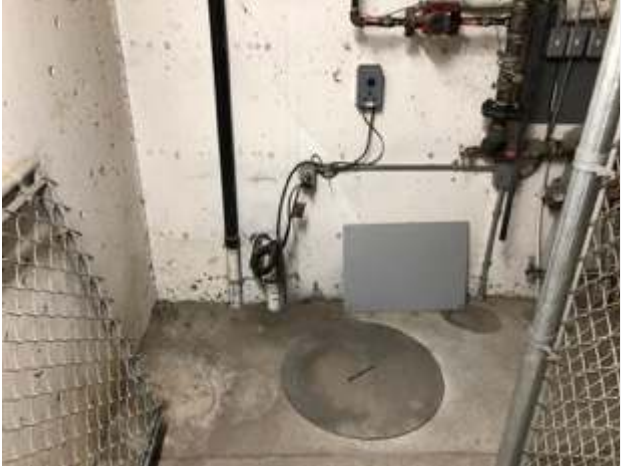
Sump pump with fail alarm		
<p>Photograph 153</p>					
<u>GOOD PRACTICE GUIDELINES:</u>					
❖ Monitor and test operation of pumps every three to four months.

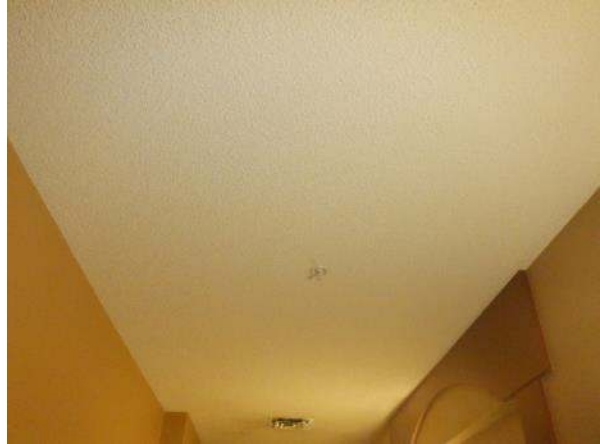
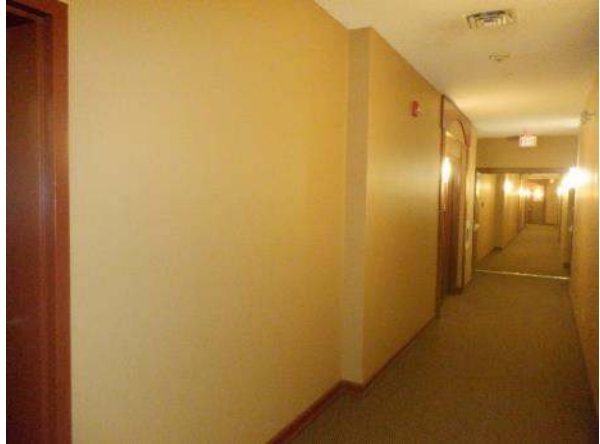
Photograph 167			Photograph 168		
Ceilings with stipple paint finish			Painted walls with smooth finish

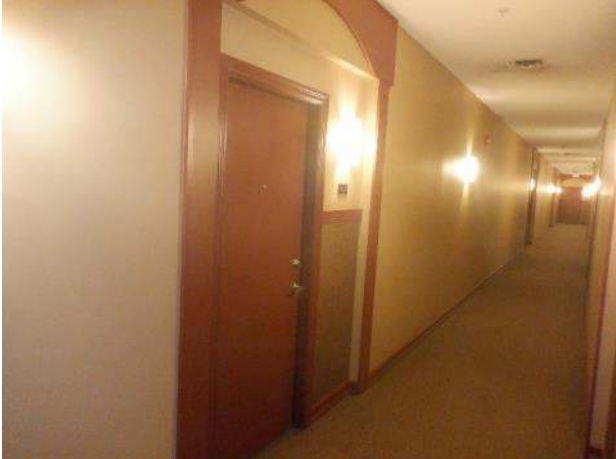
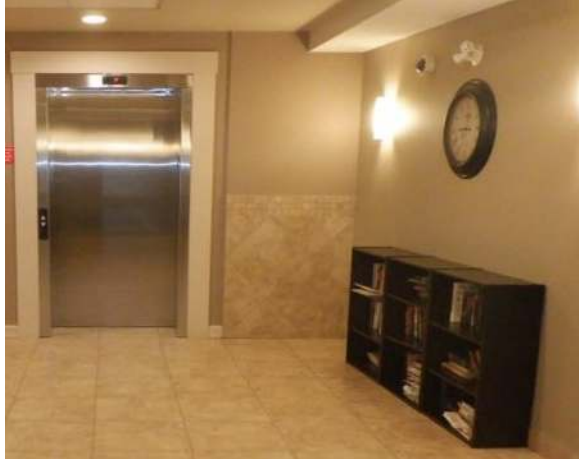
Photograph 169			Photograph 170		
Painted unit door			Wallpaper finishes		
<u>GOOD PRACTICE GUIDELINES:</u>					
❖ Repair and repaint scratches and dents in the walls as necessary.

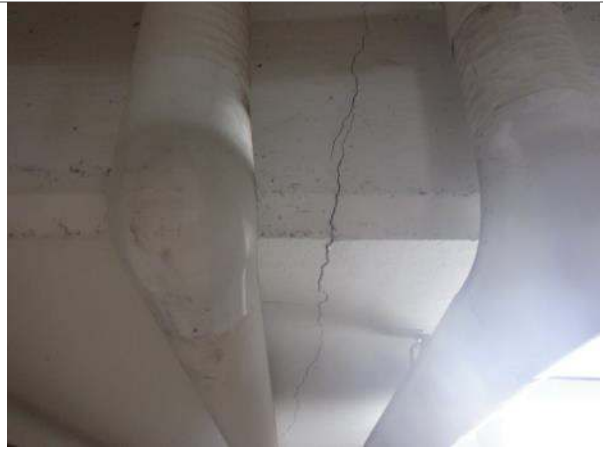
Photograph 180

Cracking on parkade walls and soffit
