# RESERVE FUND STUDY REPORT

## **MACEWAN GARDENS II CONDOMINIUM CORPORATION 263 MACEWAN ROAD, EDMONTON, ALBERTA CONDOMINIUM PLAN No. 092 4818**

**DECEMBER 2013**

**WADE ENGINEERING LTD.**  
15359-117 Avenue, Edmonton, AB T5M 3X4

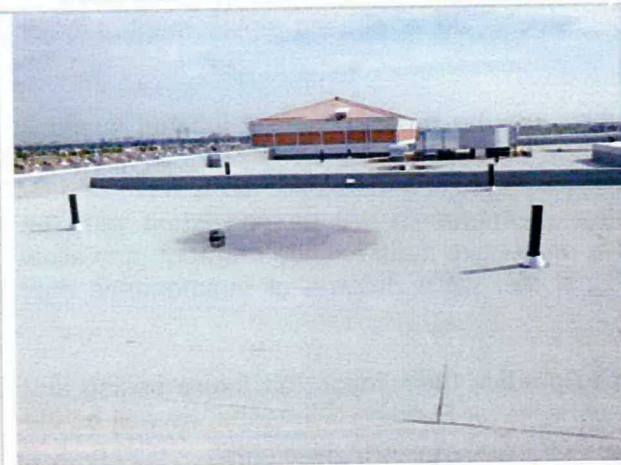
Overview of SBS roof area

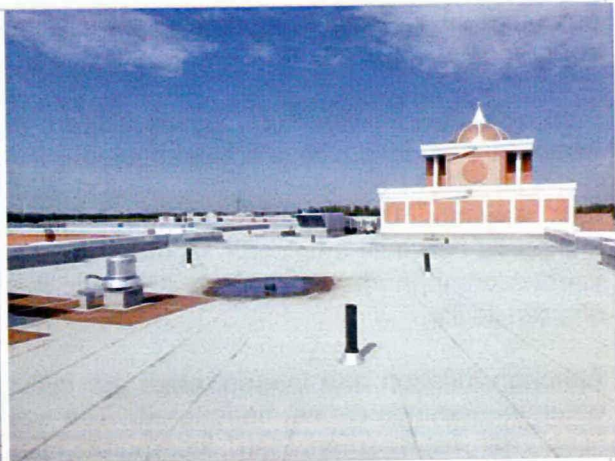
SBS roof and copper shingled architectural feature

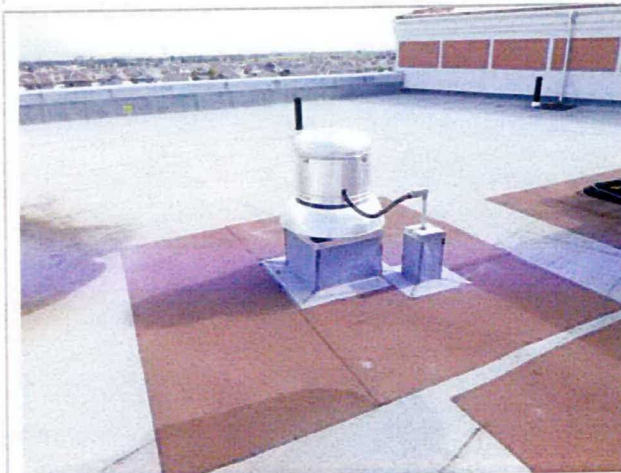
Protective layer of membrane on traffic areas

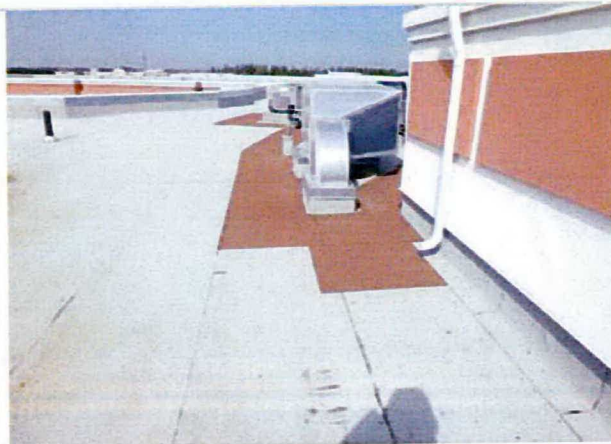
**Downspout draining onto SBS membrane roofing**

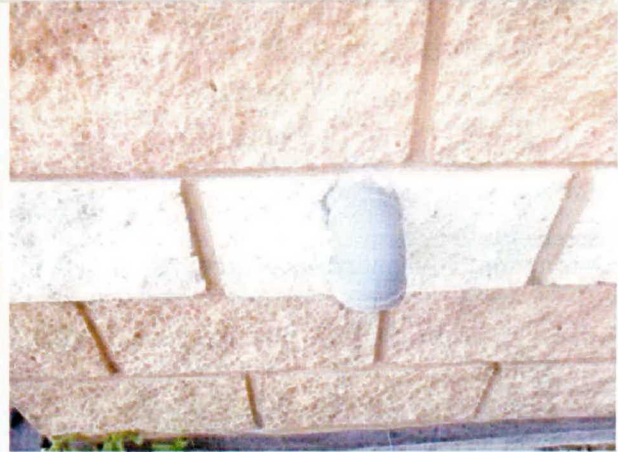
- A few wall penetrations were not sealed and may allow moisture to enter the wall system.
- Sealant is deteriorated at some balcony to wall terminations.

**Sealant around wall penetration**

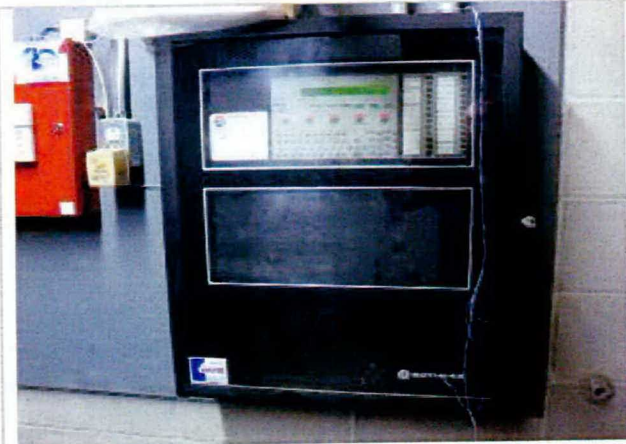
Main fire alarm

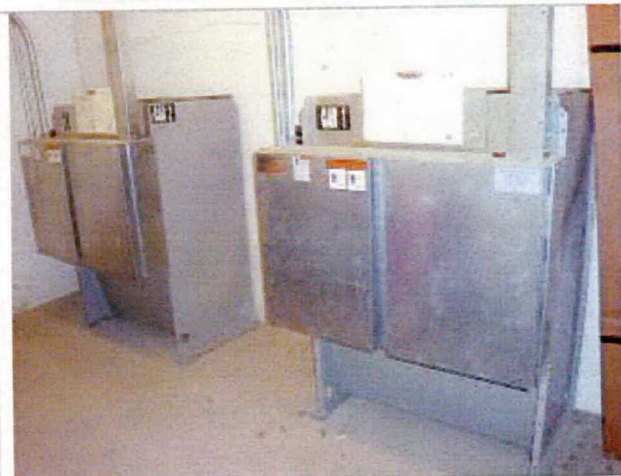
Elevator hydraulic reservoir and controls

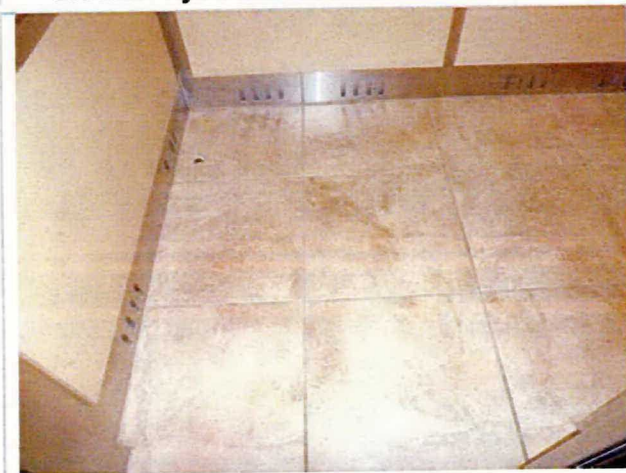
Elevator cab interior

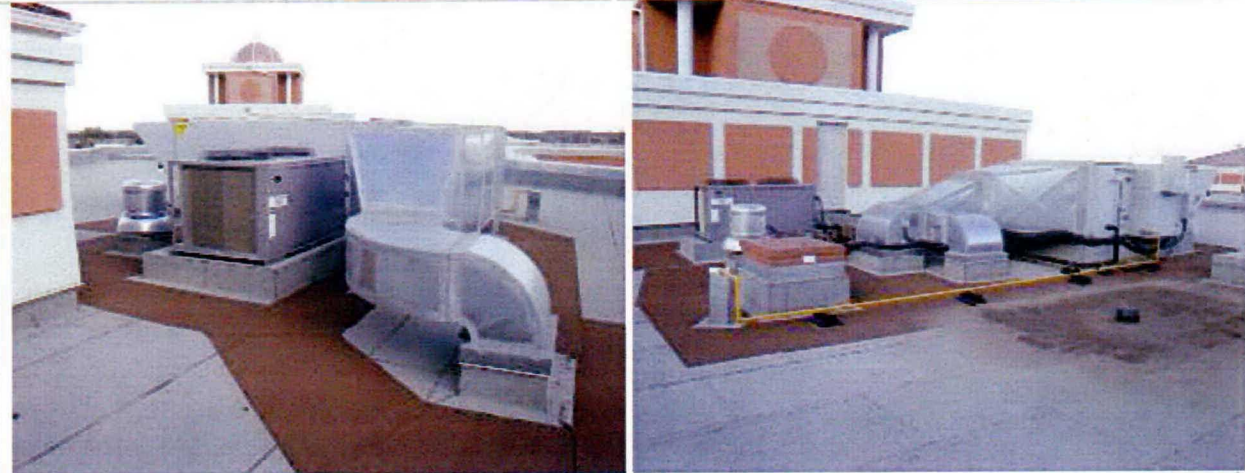
Make-up air units

- ❖ Schedule regular maintenance including replacement of filters and cleaning of fins.

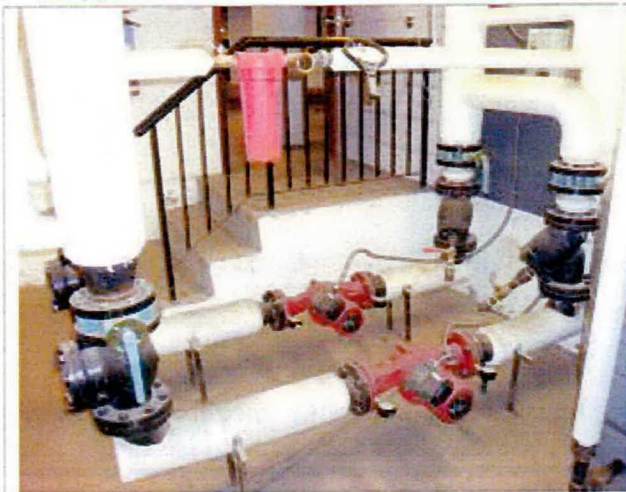
Heating supply pumps

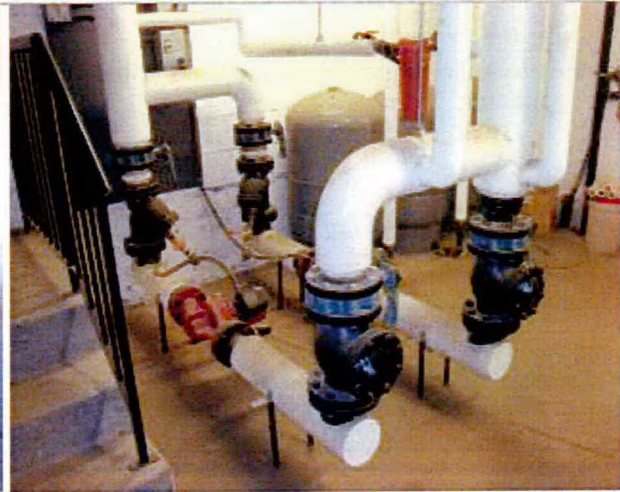
Heat loop piping and expansion tanks

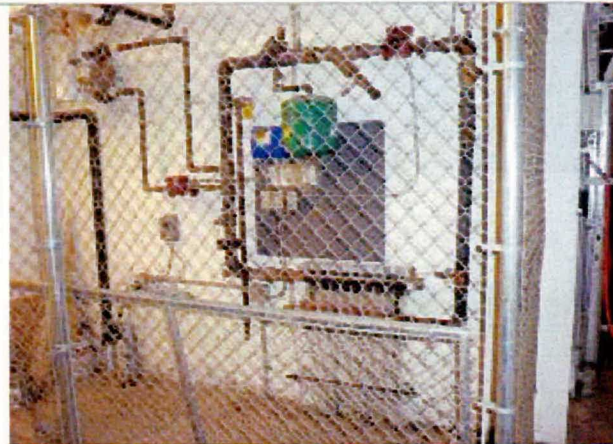
- Poured concrete parkade ramp with in-slab heating provides access into the parkade. Since the glycol loop heating piping is installed in the concrete, both components will have to be replaced at the same time when failure occurs.
- The heating is provided by the boiler hydronic system and heat exchanger and is distributed through PEX and copper piping by Grundfos pumps, model UPS26-99 with 1/6 HP and model UP15-58 with 1/25 HP.
- Tekmar snow melt controller regulates the glycol loop system.

Parkade ramp heating system

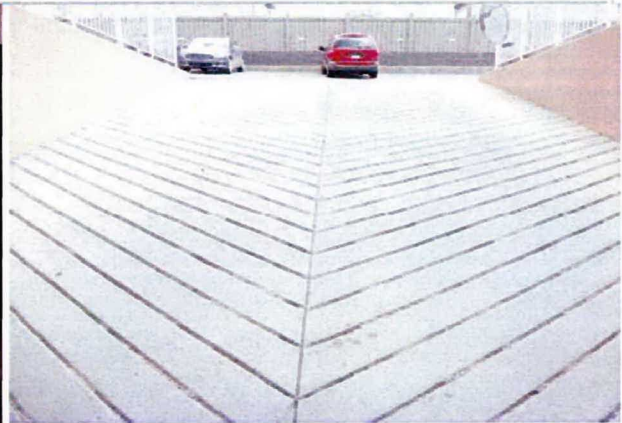
Poured concrete ramp

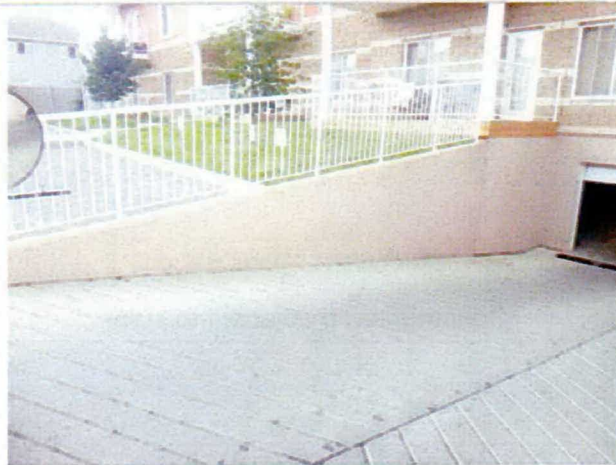
Concrete retaining wall at parkade ramp

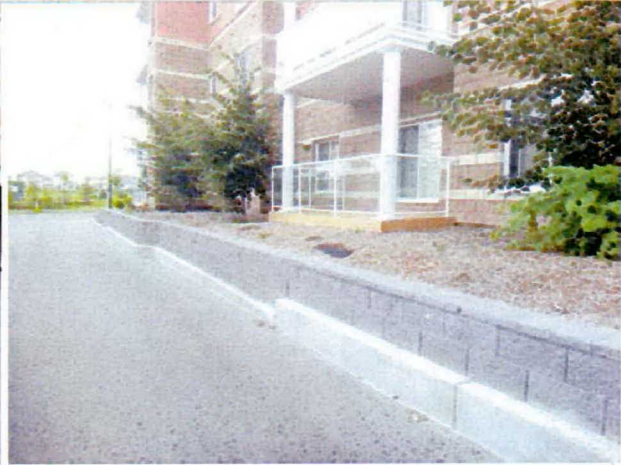
Allan block retaining wall

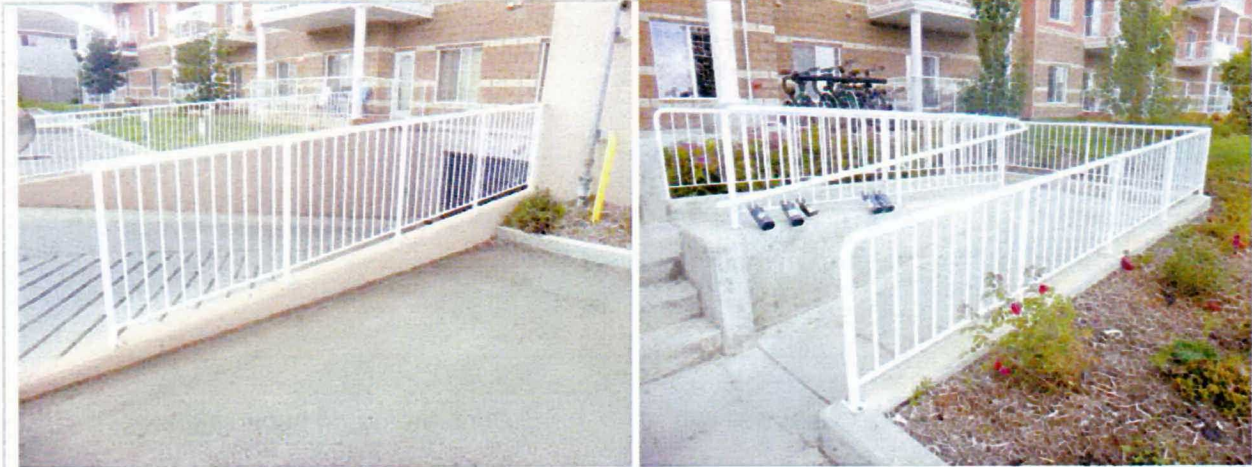
- Painted metal railings are installed on the retaining walls at the parkade ramp and front entrance ramps.

Metal railings installed on retaining walls

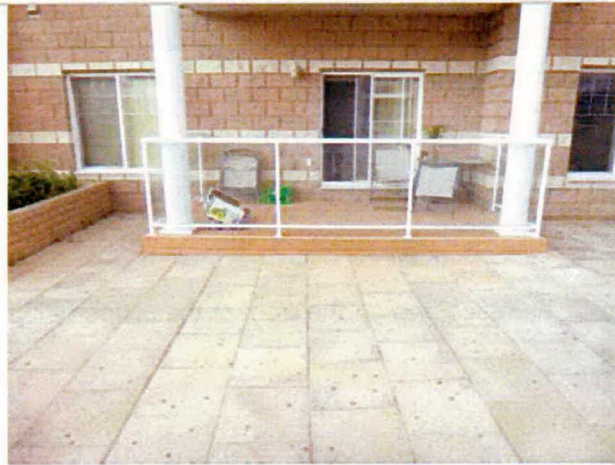
- A membrane is installed on the roof of the parkade below the composite wood decks with glass railings, concrete pavers and planters (where it extends beyond the footprint of the building). This membrane is not a life item and will require replacement. Although this membrane was not inspected, industry standard and experience suggests that this membrane will have a service life of approximately 25 years.
- In order to service the membrane the composite wood decks with glass railings, concrete pavers and planters above the membrane have to be removed and replaced. Gravel has been placed above the membrane at several locations for improved accessibility of the membrane.

Composite wood deck with glass railings
