# RESERVE FUND STUDY REPORT

## **MACEWAN GARDENS II CONDOMINIUM CORPORATION 263 MACEWAN ROAD, EDMONTON, ALBERTA CONDOMINIUM PLAN No. 092 4818**

**DECEMBER 2013**

**WADE ENGINEERING LTD.**  
15359-117 Avenue, Edmonton, AB T5M 3X4

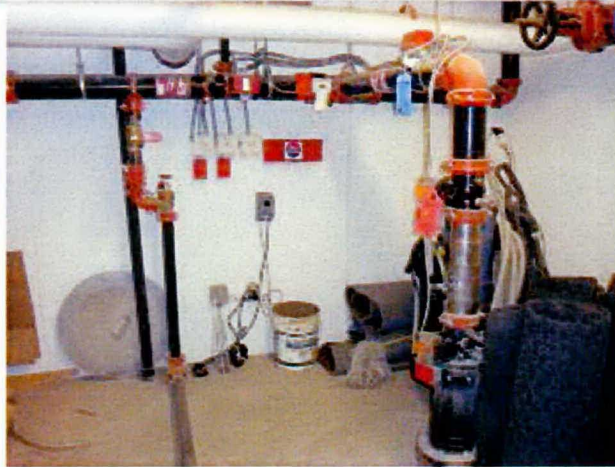
Main sprinkler connection

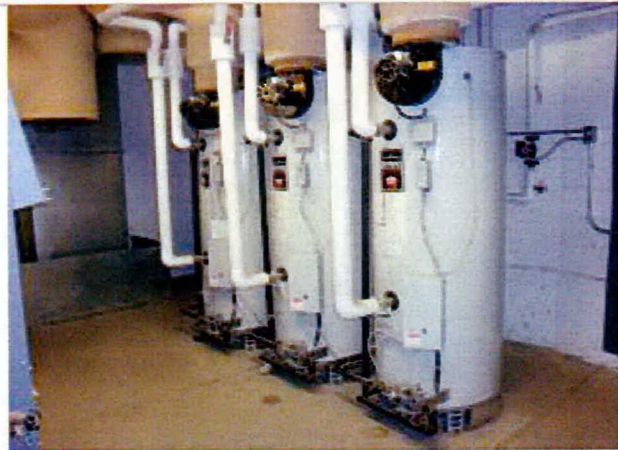
- Gas fired hot water tanks with 80 gallons and 652,500 Btu are manufactured by Bradford White, models D80T7253N.
- The temperature and pressure valves of the hot water tanks are not plumbed to drains. This can potentially cause damage to adjacent components when valves release.
- Copper and PEX piping with insulation comprise the domestic water piping. As piping ages, replacement of deteriorating sections is anticipated.
- The Grundfos 1/12 HP pump, model UPS-15-55SF, is used to recirculate water through the domestic piping.

Domestic hot water tanks

- ❖ Flush the hot water tanks annually.
- ❖ Records of leaking will suggest the need for piping replacement.
- ❖ Schedule regular maintenance.

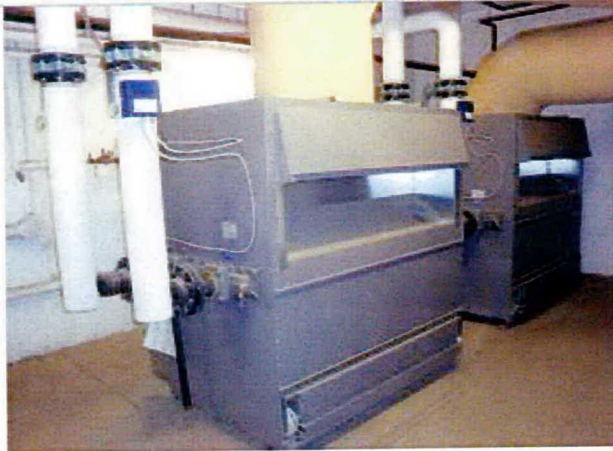
- The gas fired hot water boilers are manufactured by Laars, models HH2450IN11K1CCTC with 2,450,000 Btu input, and provide heat to the hydronic radiant heat loop system.
- The temperature and pressure valves of the boilers are not plumbed to drains. This can potentially cause damage to adjacent components when valves release.
- A 5-storey single stack insulated boiler flue is tied into each boiler.
- Tekmar, model 264, 4-stage controller regulates the boiler system.

**Boilers**

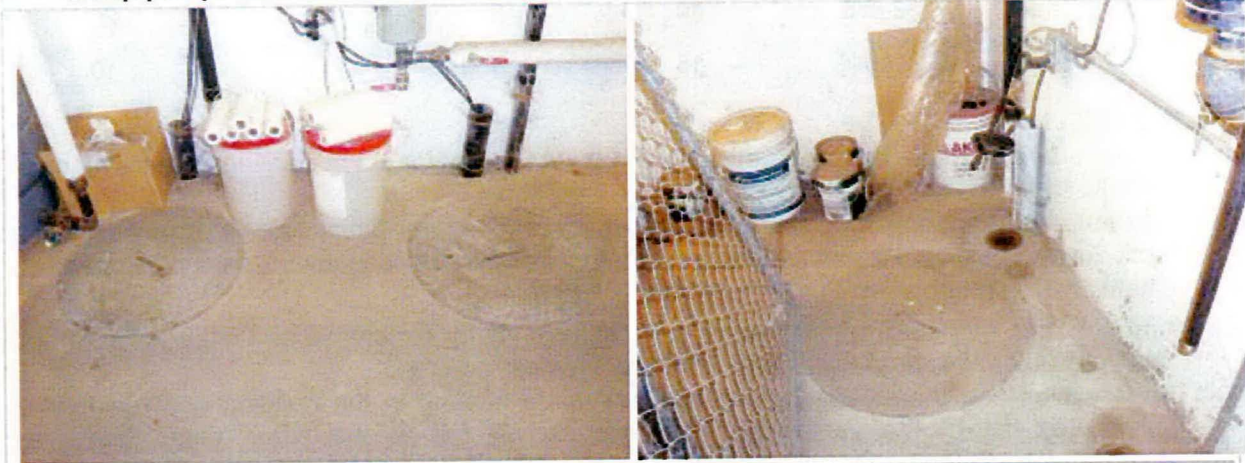
- Sump pumps with fail alarms are installed in the mechanical room and parkade.

Sump pumps

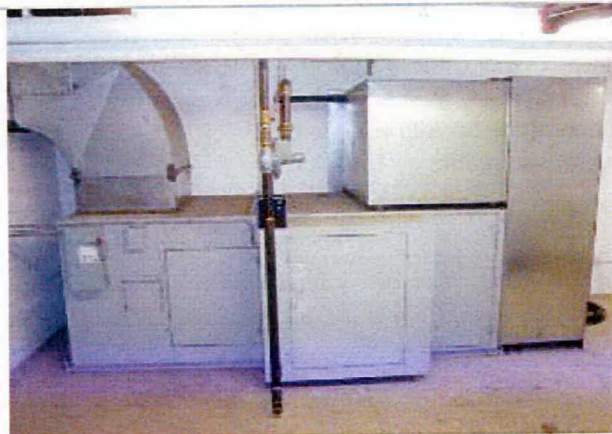
- Make-up air unit in the parkade was manufactured by Engineered Air, model HE-221 with 2,494,800 Btu, and supplies fresh air to the underground parking space.

Parkade make-up air unit

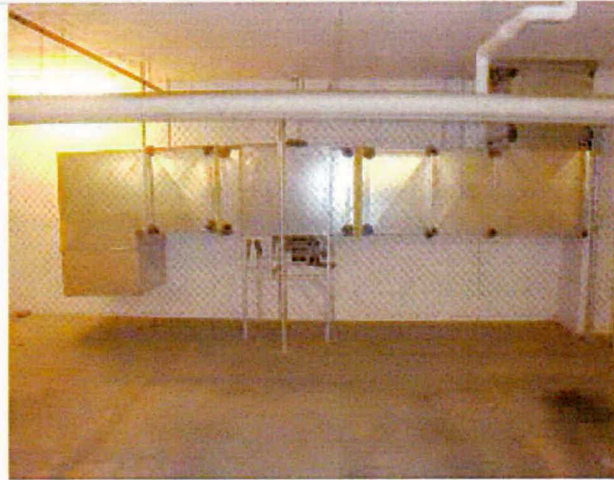
Parkade exhaust fan

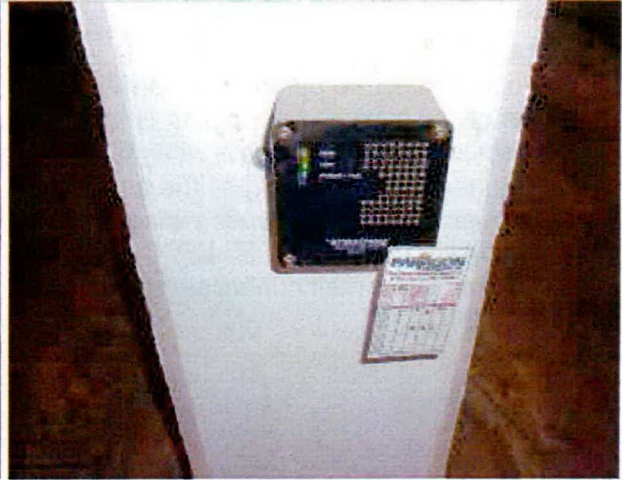
Gas monitor

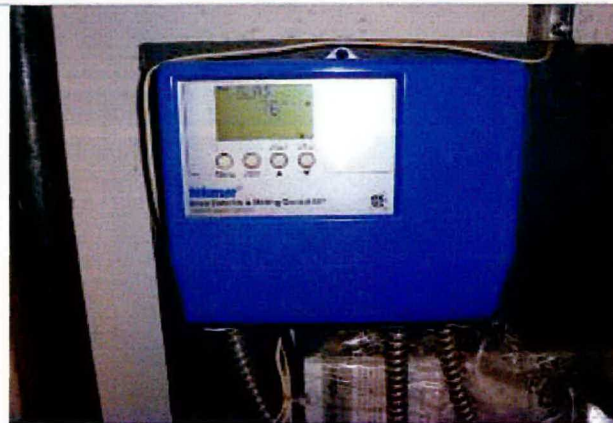
Tekmar snow melt controller

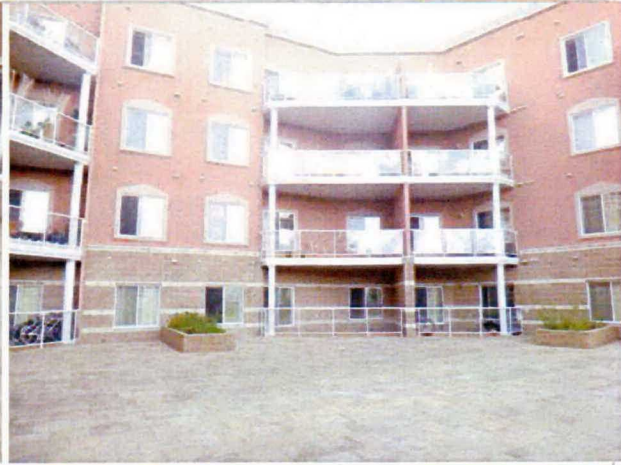
Concrete pavers and planters with shrubs

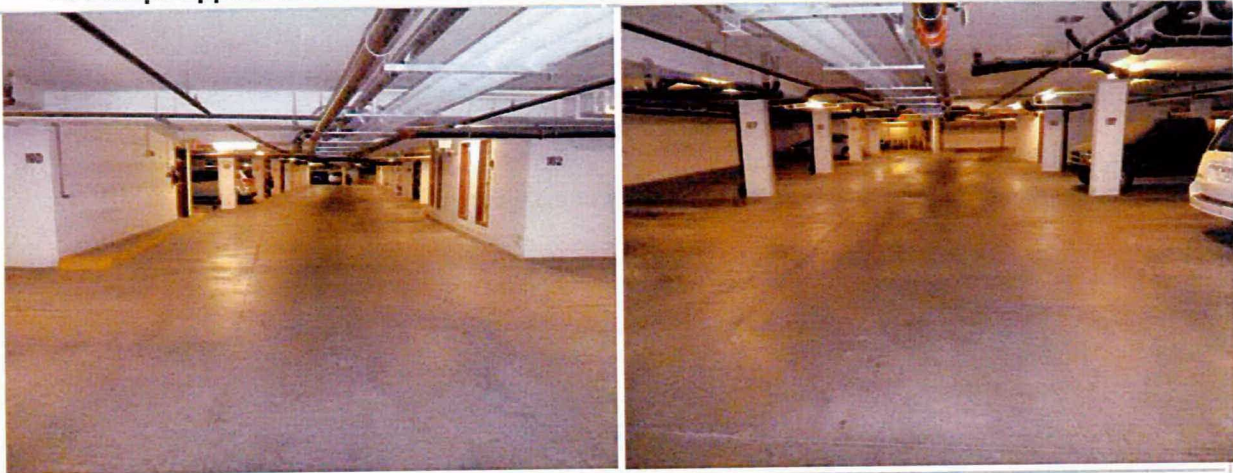
- There is an underground parkade below the building and extends beyond the footprint of the building on the south side.
- Fire stops appear to be installed in the soffit penetrations.

Overview of parkade
