RESERVE FUND STUDY REPORT

**MACEWAN GARDENS II
CONDOMINIUM CORPORATION
263 MACEWAN ROAD, EDMONTON, AB
CONDOMINIUM PLAN No. 092 4818**

**DECEMBER 2019
REPORT AMENDED (AUGUST 2021)**

**WADE ENGINEERING LTD.**
15359-117 AVENUE, EDMONTON, AB T5M 3X4

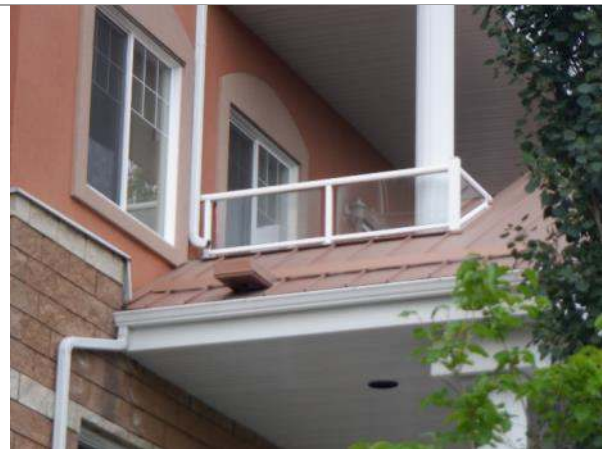
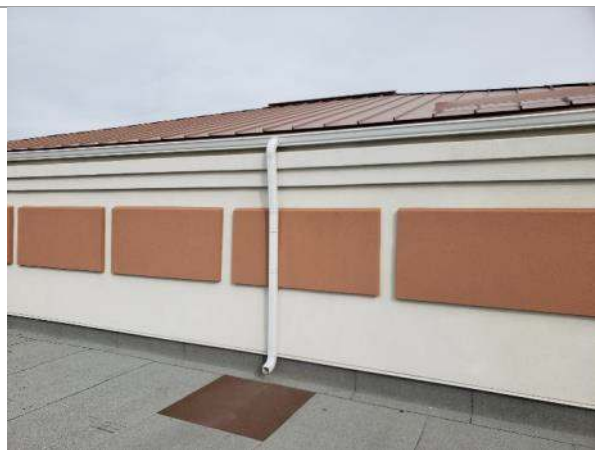
Overview of eavestroughs and downspouts (upper roof level & canopy entrance)

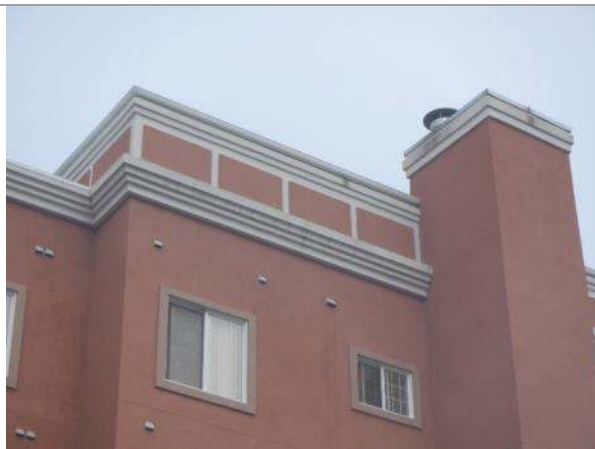
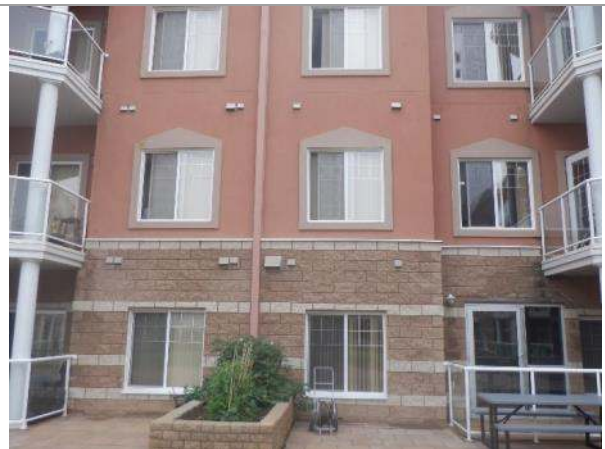
Rooftop perimeter cornices and accent trims around windows & doors are clad with Exterior Insulation Finish (EIFS)

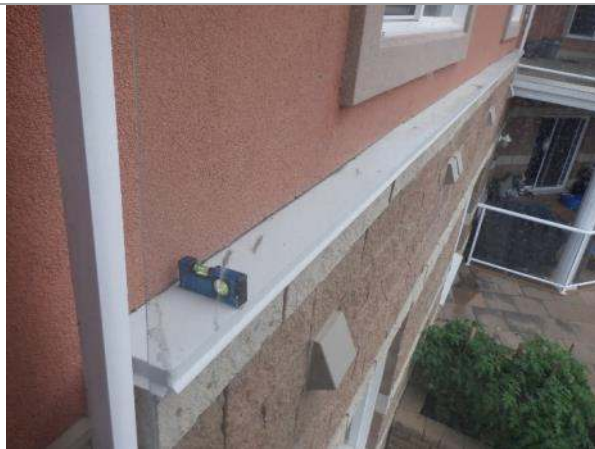
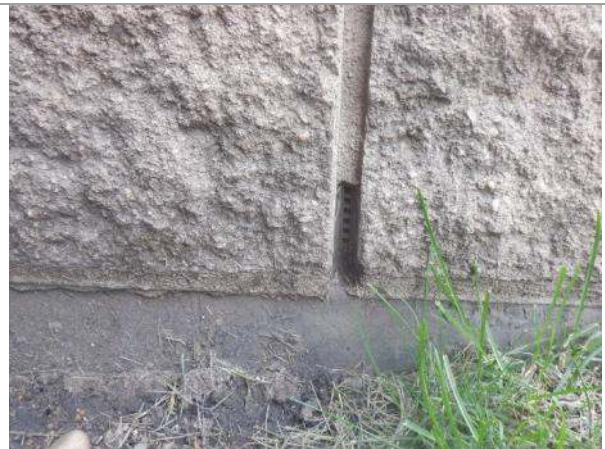
Horizontal prefinished metal cap flashing at stucco to stone block veneer transition

Weep hole in stone block veneer clear of debris

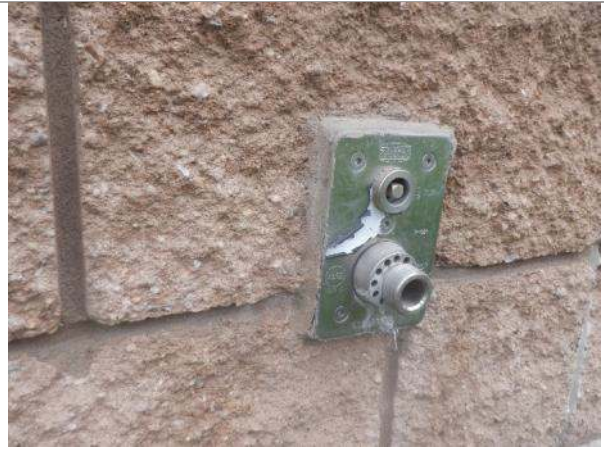
Photograph 27

Sealant around wall penetration

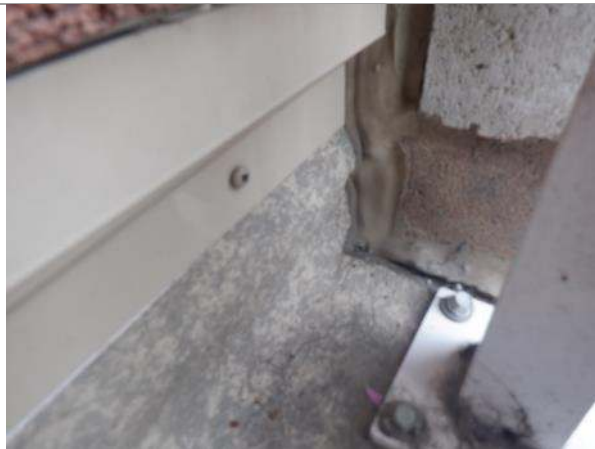
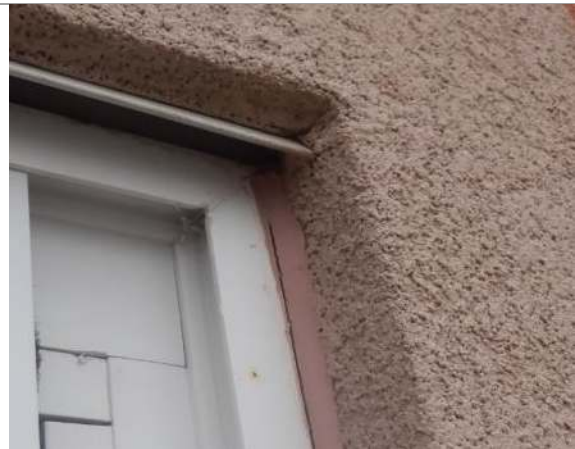
Sealant application at balcony corners and around windows

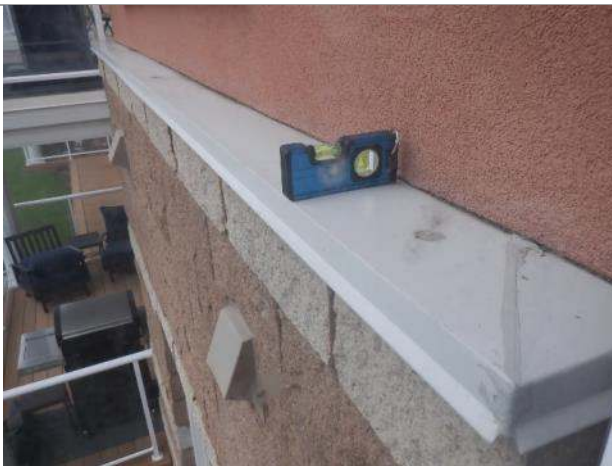
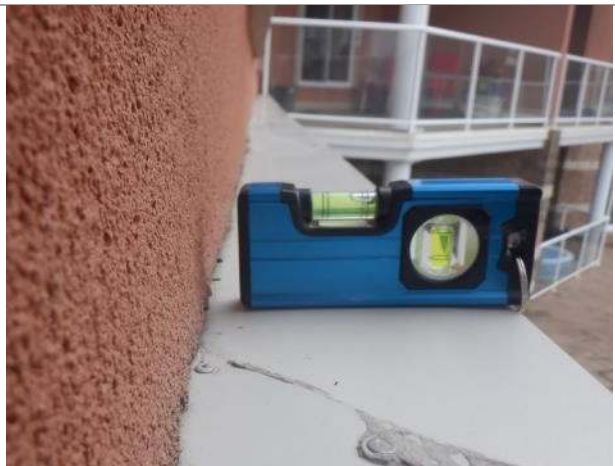
Negative slope noted on prefinished metal cap flashings

- **Balconies (Pg. 22):** Due to staining noted on stucco, stone block veneer and locations with negative and lifted cap flashings, a building envelope investigation should be scheduled to determine an appropriate course of action for repair. Replace deteriorated sealant and seal wall penetrations where required. Work to scheduled to be completed 2021/2022.
- **Landscaping (Pg. 32):** The Corporation is completing some regrading around the building in 2021.

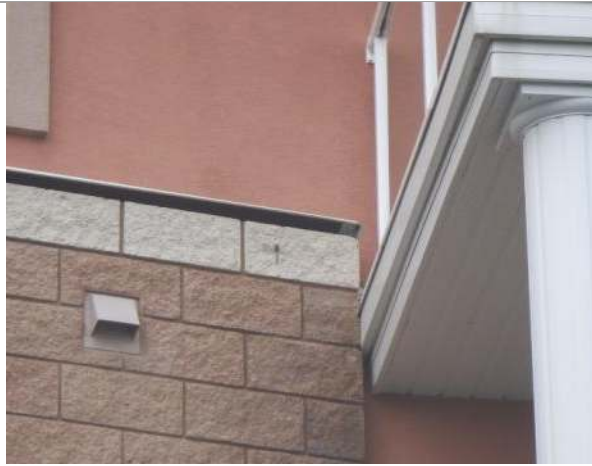
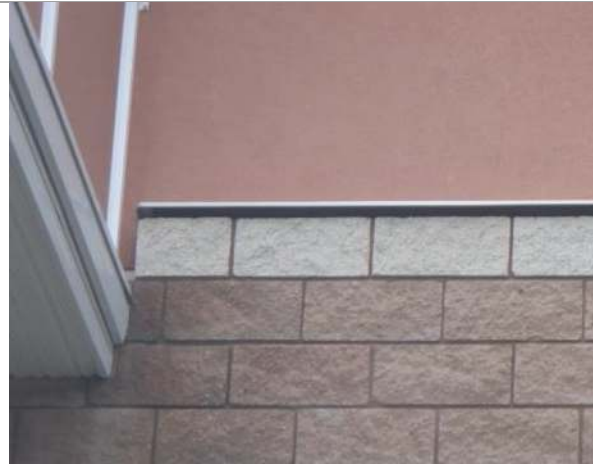
Lifted prefinished metal cap flashings above stone block veneer wall

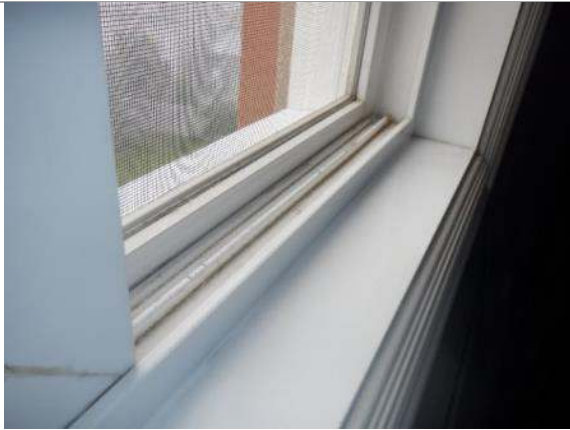
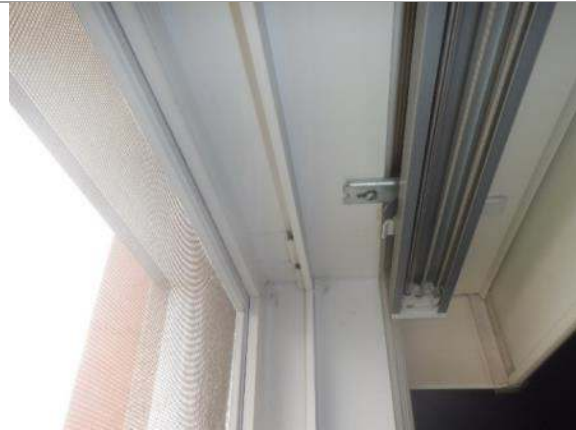
Window sill and head with PVC Jamb extensions

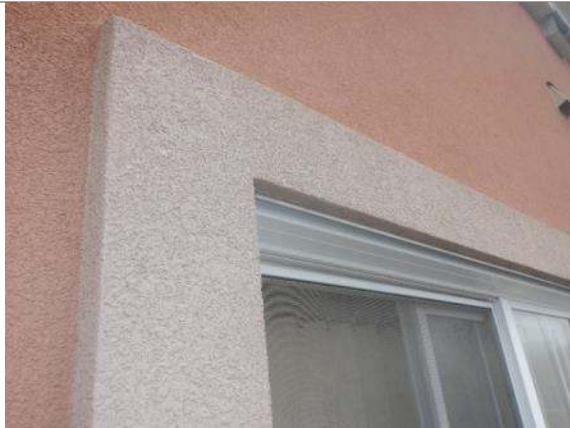
Photograph 40

Window head flashing

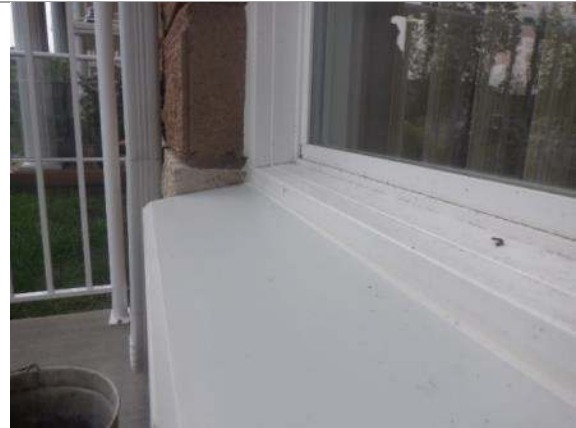
Photograph 41

Window sill flashing on brick veneer cladding

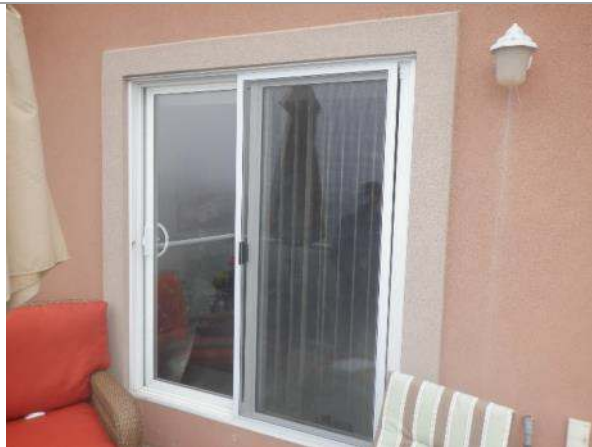
Photograph 42

Horizontal slider door

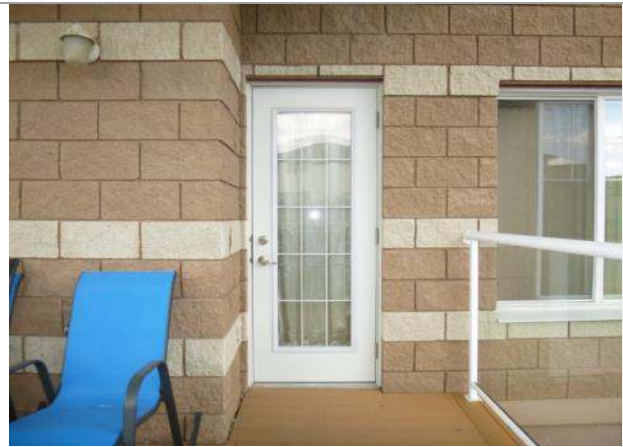
Photograph 43

Hinged patio door

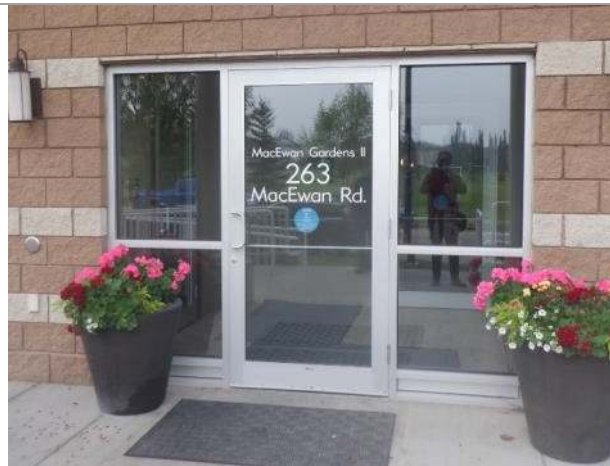
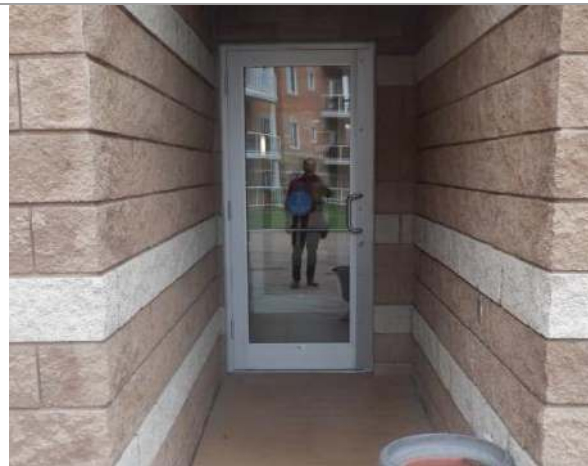
Overview of storefront style doors

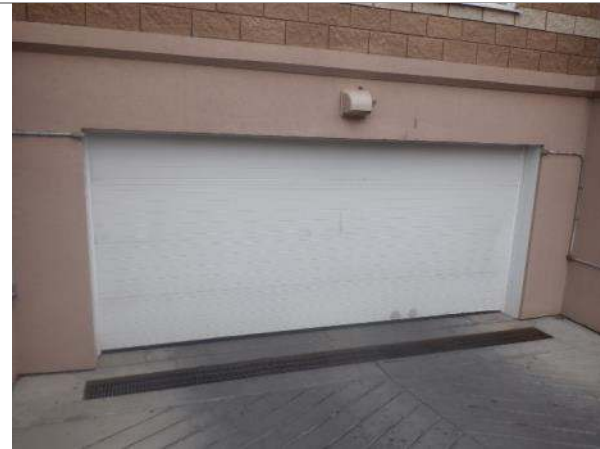
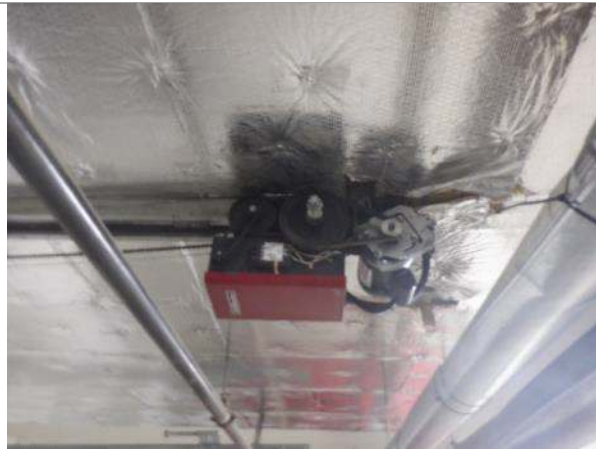
Parkade overhead door and motors & controls

- ❖ Regular maintenance of doors includes periodic inspection for failed weather stripping, sealant and damaged or inoperable hardware.
- ❖ Sealant must be kept in good condition and replaced in a timely fashion.

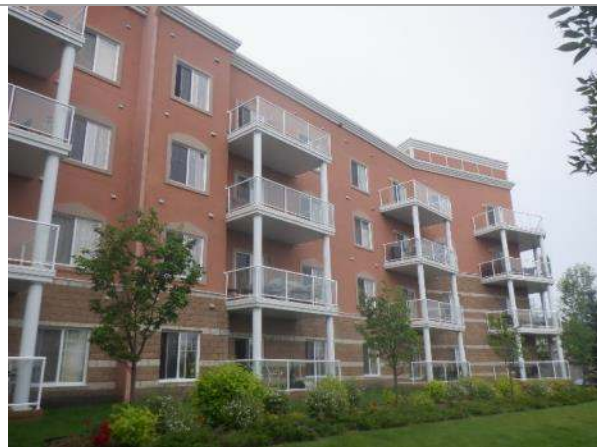
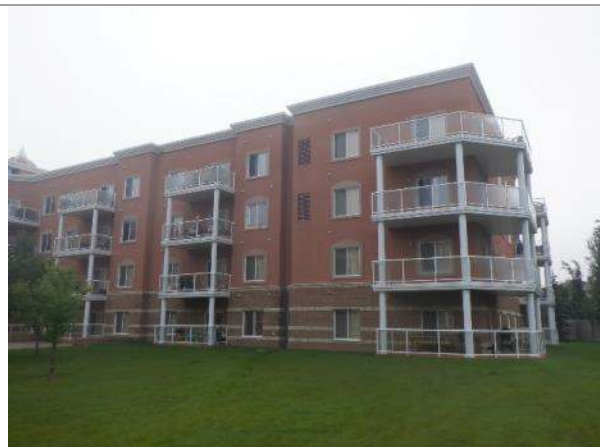
Overview of balconies configuration

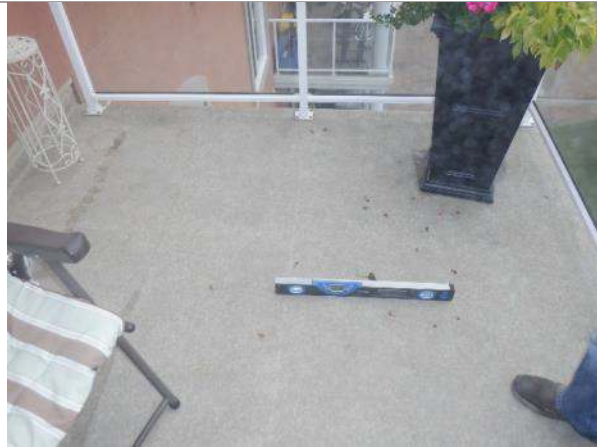
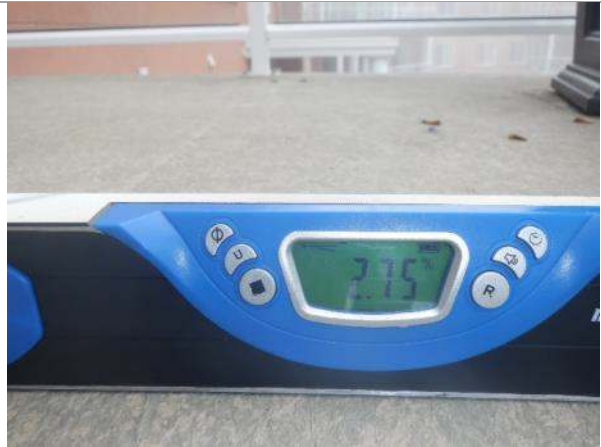
PVC membrane with positive deck slope

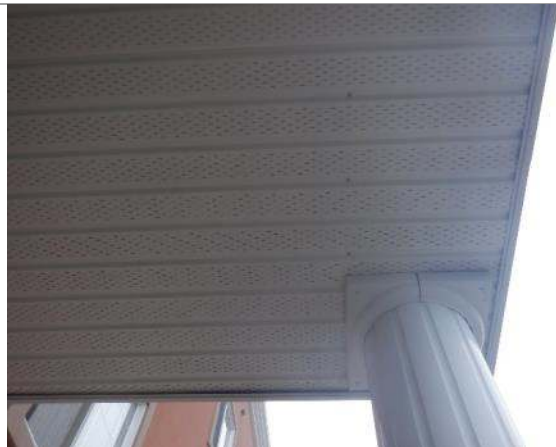
Photograph 52

Perforated prefinished metal soffit

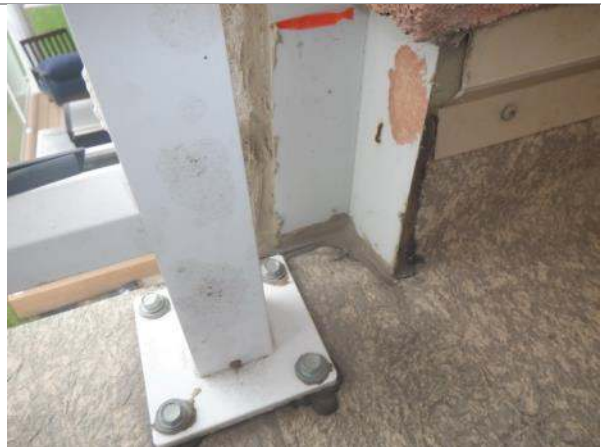
Photograph 53

Sealed balcony guardrail fasteners and corners

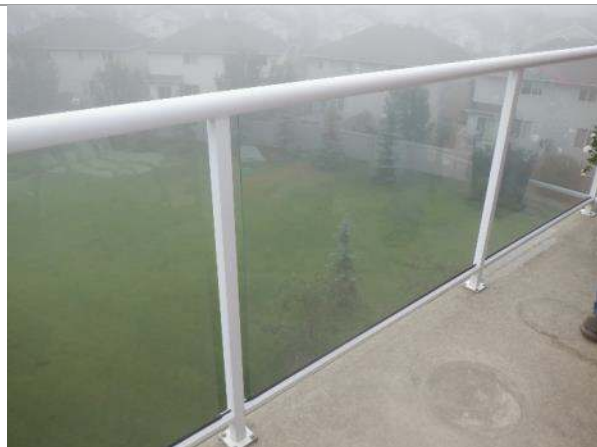
Photograph 54

Balcony guardrails with glass inserts

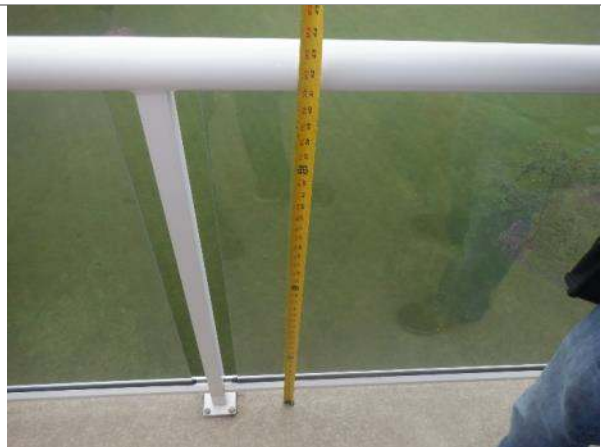
Photograph 55

Guardrail height meets code requirements

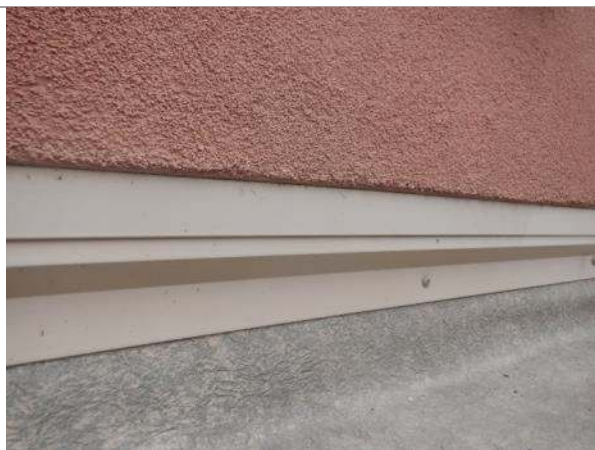
Photograph 56

Membrane lapped up the walls and terminated with clamping bar

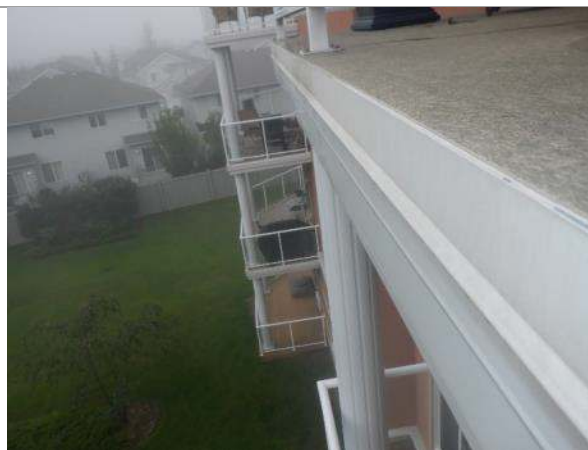
Photograph 57

Balcony prefinished metal drip edge and fascia

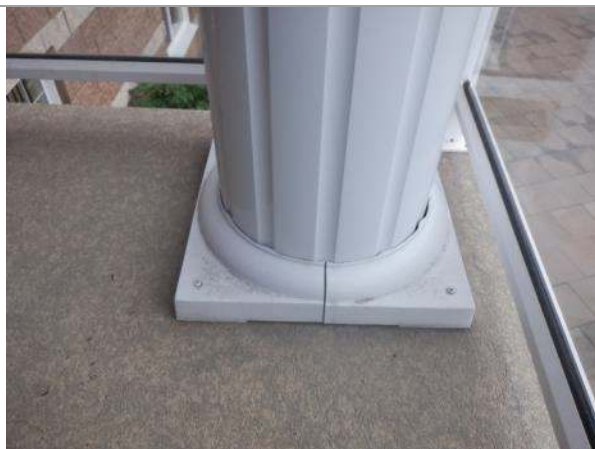
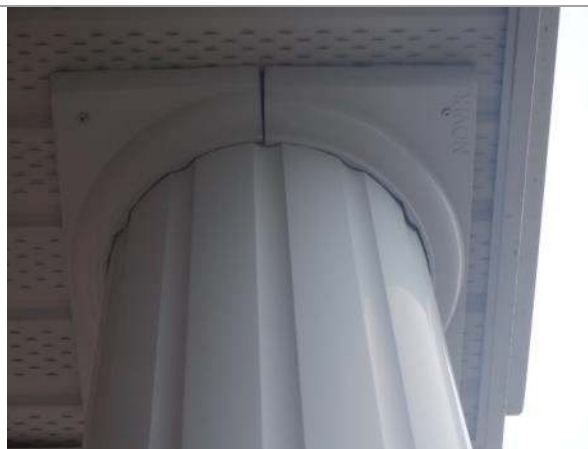
Prefinished metal clad balcony support columns

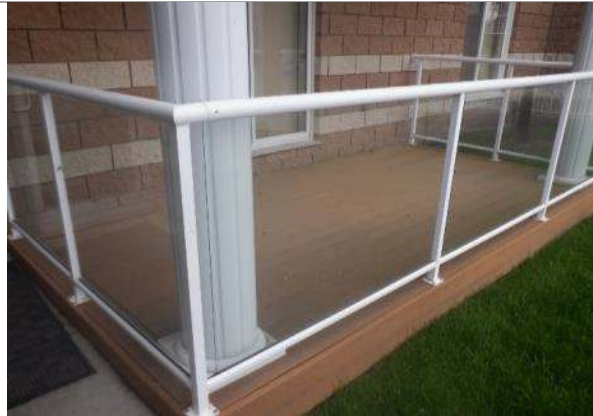
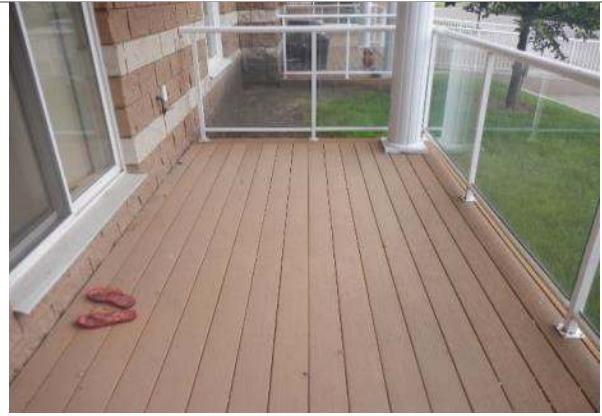
Overview of composite wood decks with guardrails

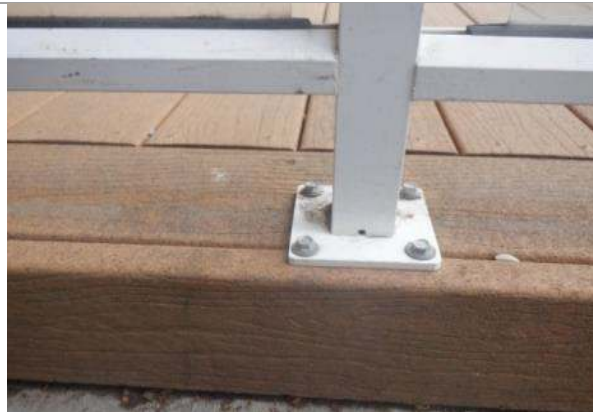
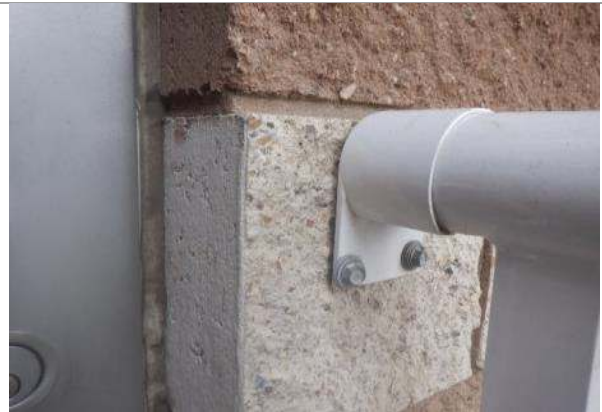
Guardrails securely fastened onto deck assembly and adjacent wall

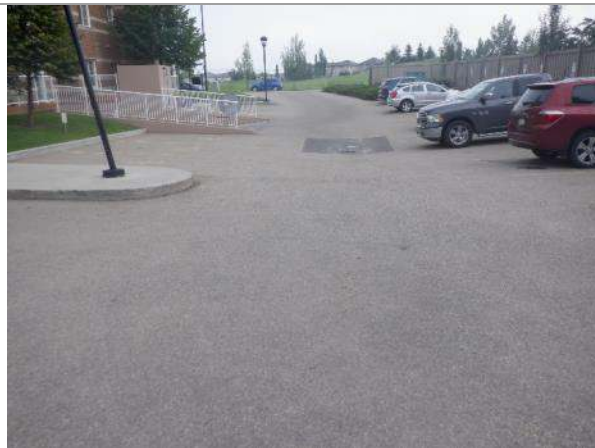
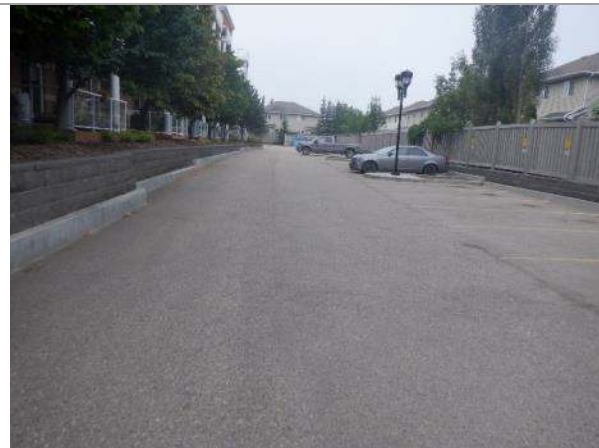
Asphalt parking and drive surfaces

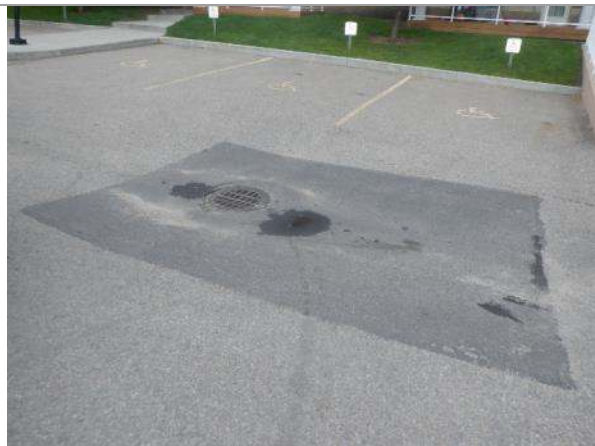
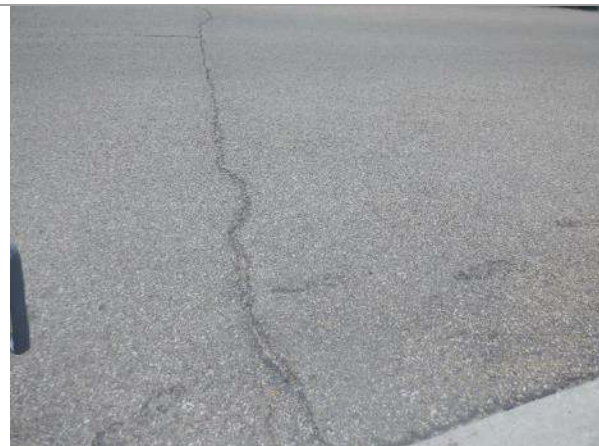
- No major concerns were noted with the asphalt surface.
- Evidence of previously repaired sections were noted around the storm sewer drain areas.
- Minor cracking was evident at some locations.

Previously repaired sections around storm drain and minor cracking on asphalt surface

- ❖ Schedule regular maintenance including localized sealing of cracks and patch repairs to realize the expected life of the asphalt.
- ❖ Seal cracks as they occur.

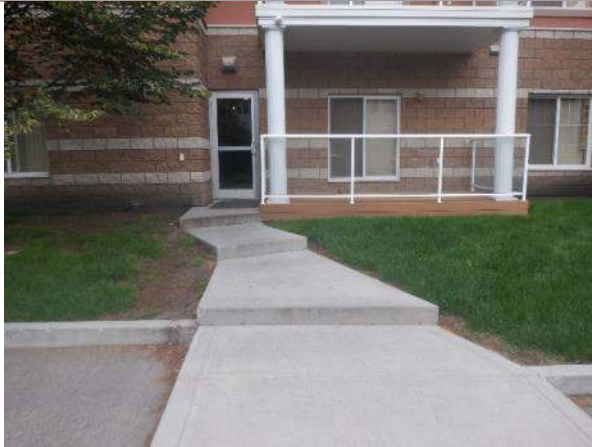
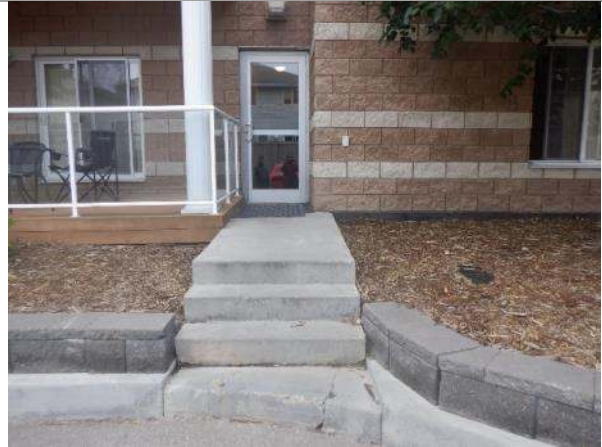
Poured concrete walkways and steps

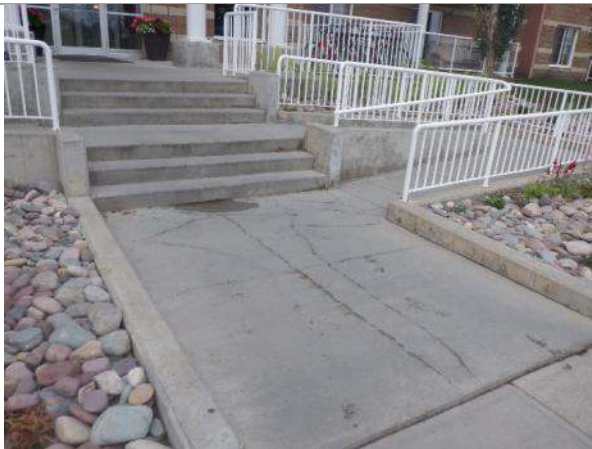
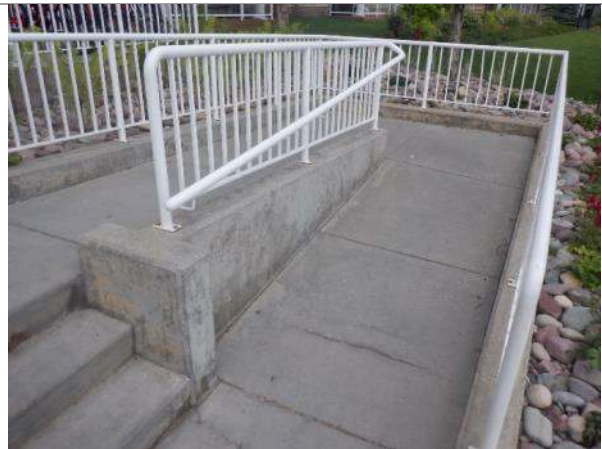
Poured concrete steps and wheelchair ramp

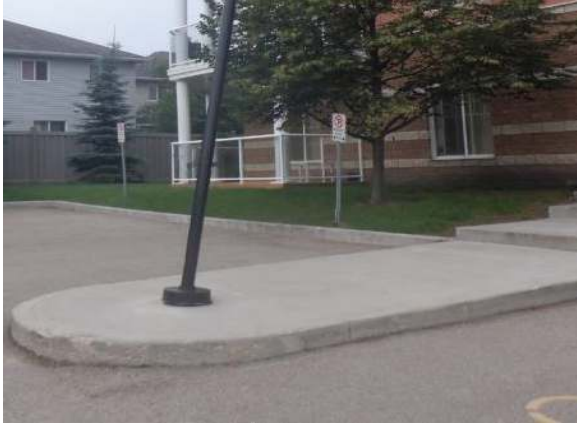
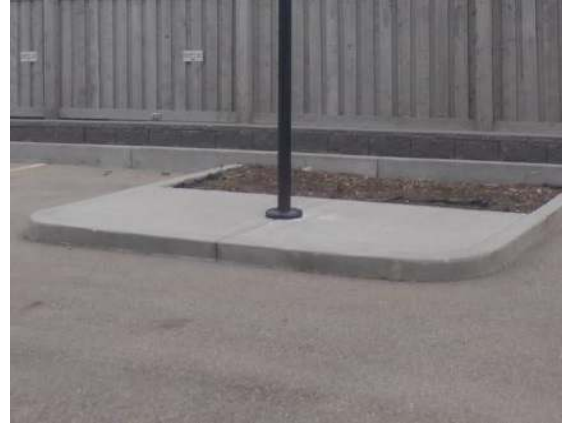
Poured concrete islands

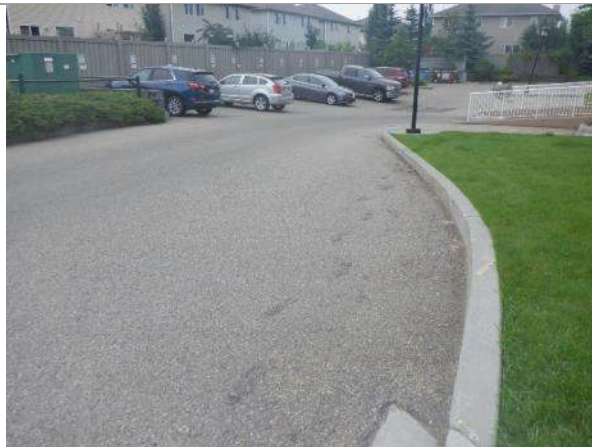
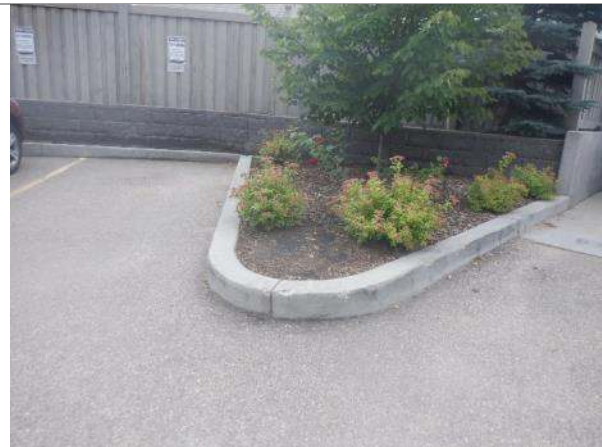
Overview of poured concrete curbs

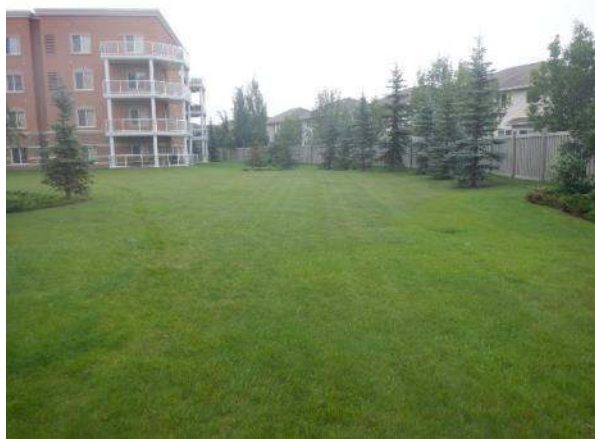
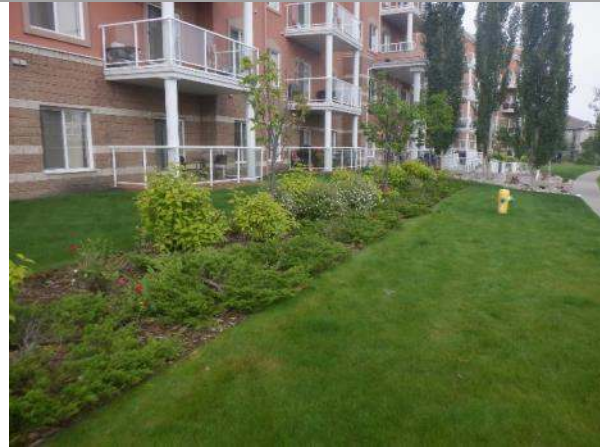
Overview of landscaping

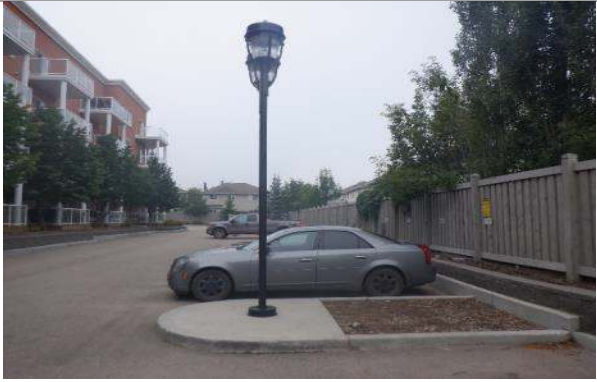
Light standard		
GOOD PRACTICE GUIDELINES:					
❖ Weekly walk around to ensure lighting is working properly.

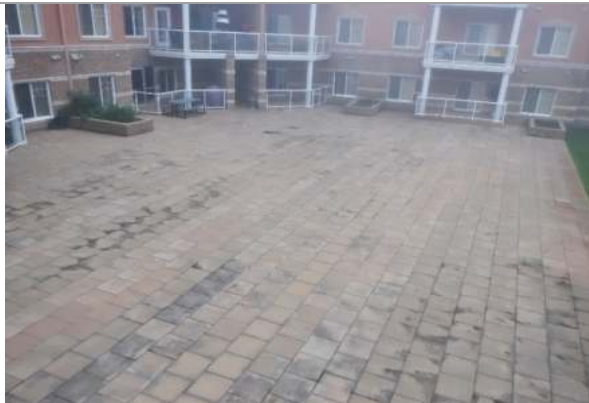
Overview of concrete pavers and planters over parkade membrane

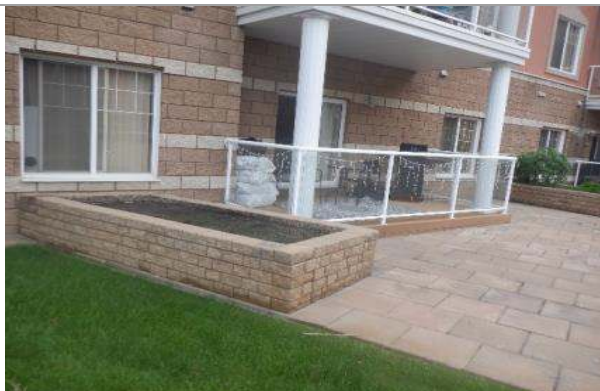
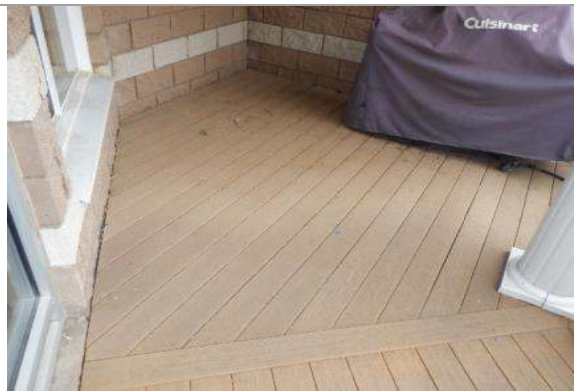
Overview of composite wood decking, guardrails and planter beds

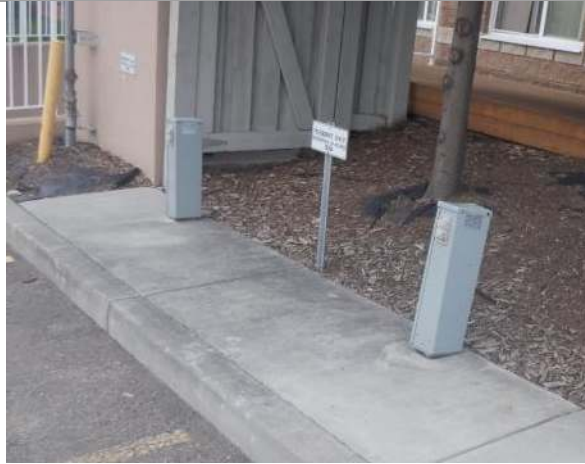
Photograph 86

- No concerns were noted with the power pedestals and outlets.

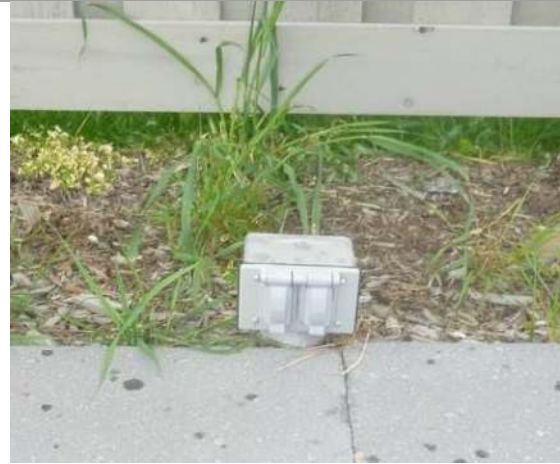
Photograph 87

Power pedestals and outlets

- ❖ Repair leaning pedestals to ensure proper operation.

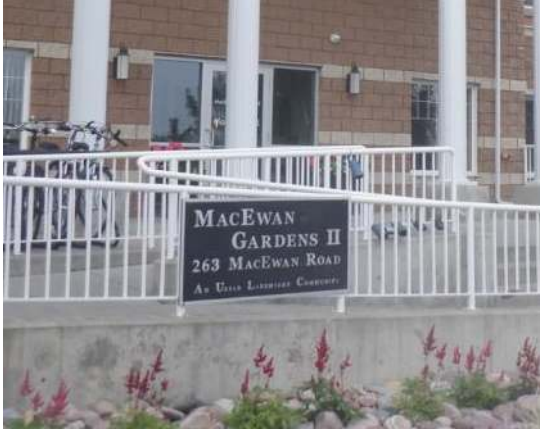
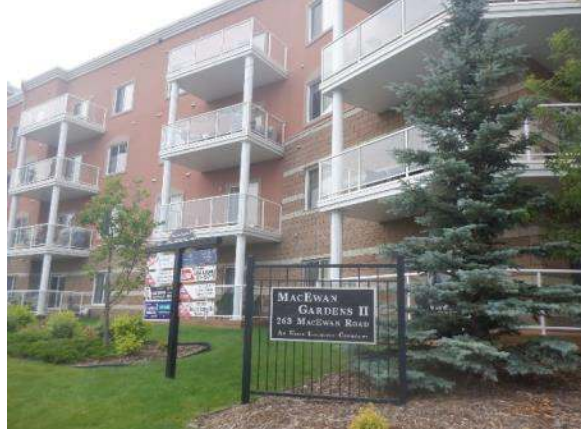
TYPE OF COMPONENT(S): Property signage				OVERALL CONDITION: Good	
CURRENT REPLACEMENT COST:	EXPECTED LIFE:	ACTUAL AGE:	EFFECTIVE AGE:	REMAINING LIFE:	
\$2,100	40	11	11	29	
COMPONENT DESCRIPTION:					
<ul style="list-style-type: none"> Property signs are located by the main entrance of the building and along the east and west side entrances to the property. 					
CONDITIONS NOTED:					
<ul style="list-style-type: none"> No concerns were noted with the property signage.

Photograph 88			Photograph 89		
Property signage					
GOOD PRACTICE GUIDELINES:					
<ul style="list-style-type: none"> Clean and repair signage as required.

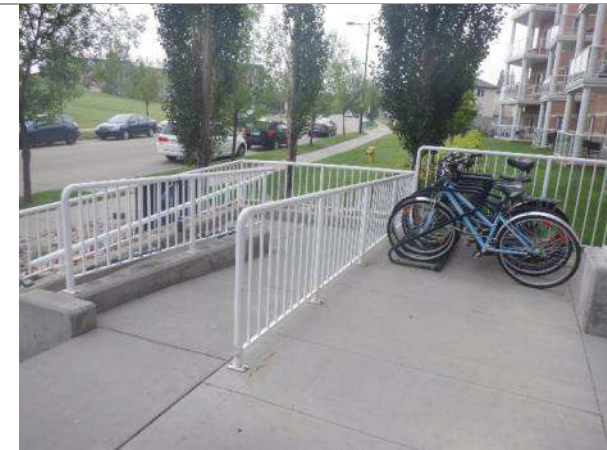
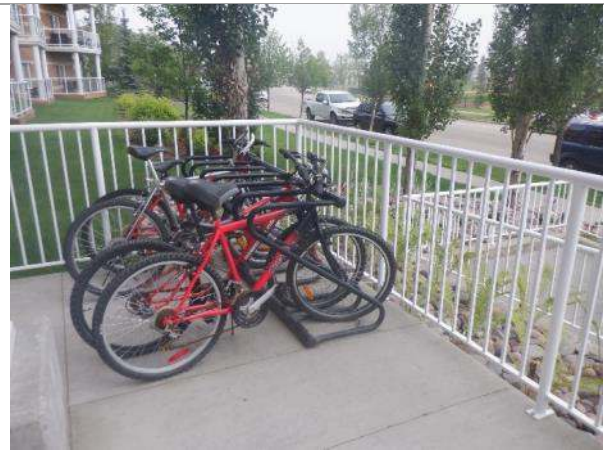
- No concerns were noted with miscellaneous metal components.

Painted metal railings alongside wheel chair ramp and bicycle racks

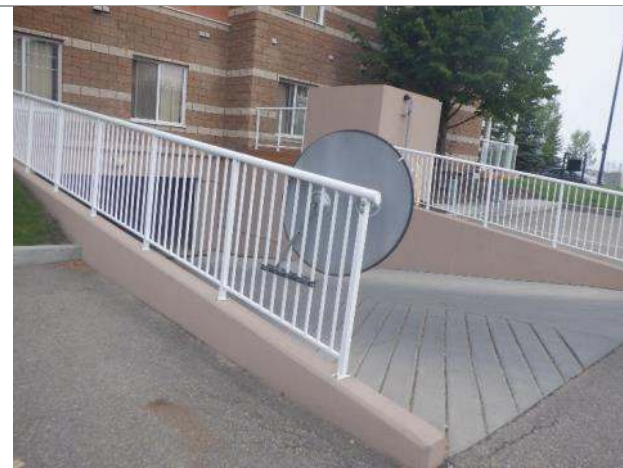
Photograph 92

Painted metal railings on parkade ramp retaining walls

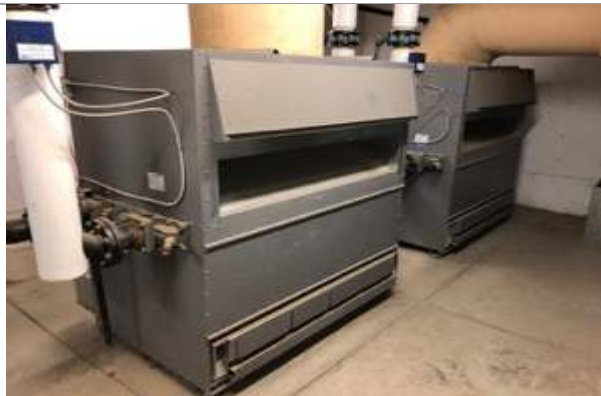
Photograph 95

- No concerns were noted with the boiler system.
- A hydronic treatment is in place and is tested annually.

Boiler

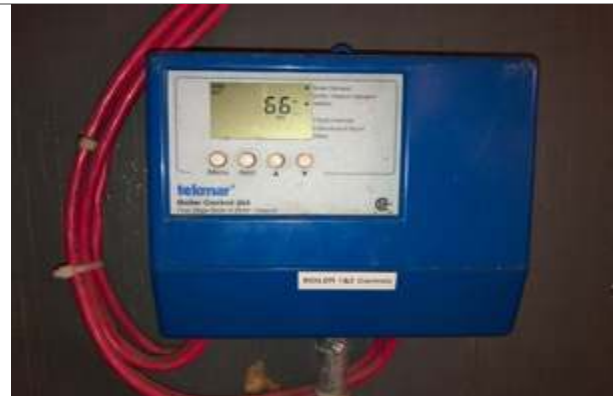
Photograph 96

Controller

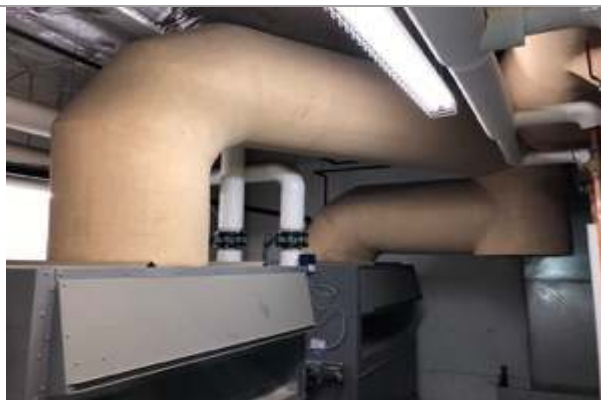
Photograph 97

Boiler flues

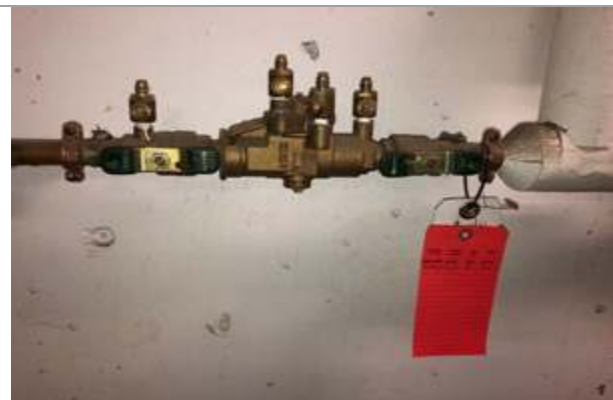
Photograph 98

Backflow protection

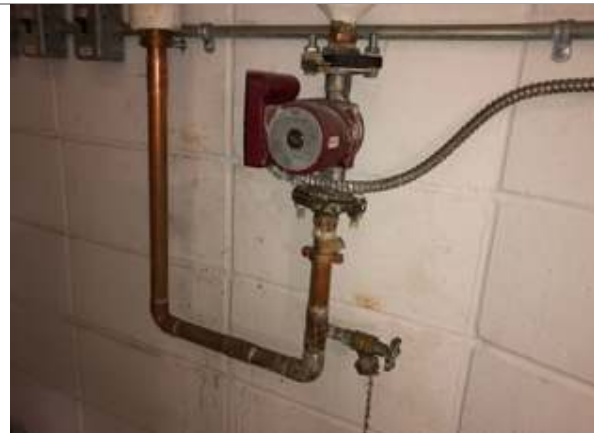
Photograph 100
Recirculating pump

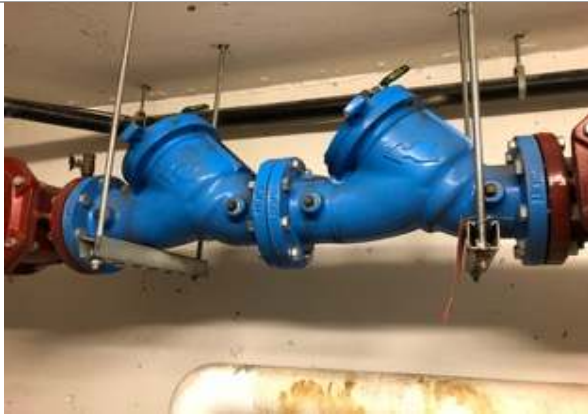
Photograph 101

Backflow prevention

- ❖ Flush the hot water tanks annually.
- ❖ Record and monitor frequency of leaks to determine repair/replacement requirements.
- ❖ Schedule regular maintenance and complete annual inspection of backflow prevention.

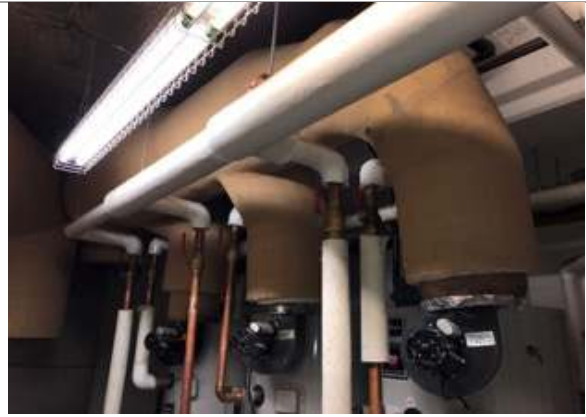
Photograph 102

- Due to the age of the hot water tanks, replacement should be anticipated in the next few years.
- Insulation has been installed on some sections of piping. As piping ages, replacement of deteriorating sections is anticipated.
- No concerns were noted with the recirculating pump.
- No concerns were noted with this backflow device during the review.

Note: Monies carried for piping replacement can be phased as the building ages as it is not thought that all piping will require replacement at the same time.

Domestic water piping

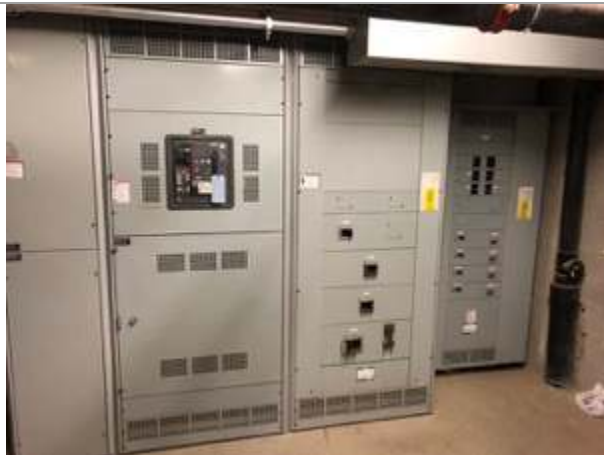
Photograph 103

- No concerns were noted with the electrical system.

Main switchgear and disconnect

- ❖ Schedule regular maintenance.
- ❖ Complete thermal scan by a certified electrician if concerns are noted.

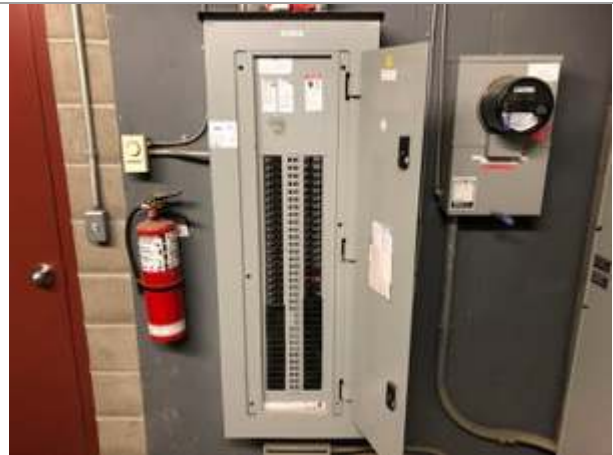
Photograph 104

Breaker panel and meter socket

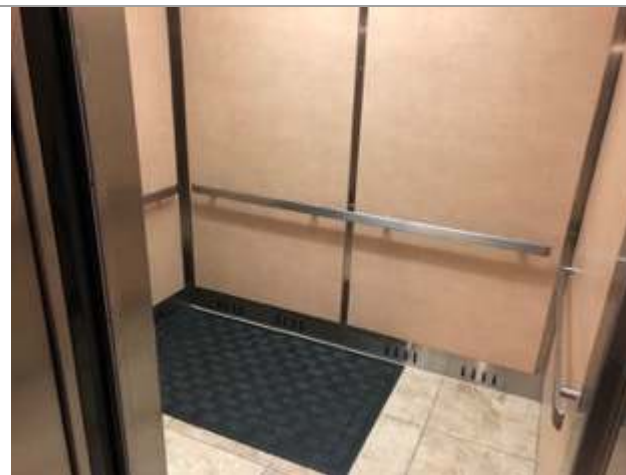
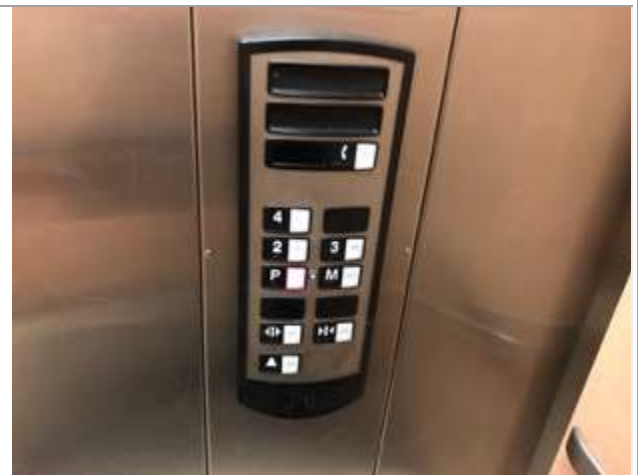
- No concerns were noted with the elevators.

Interior of elevator cab

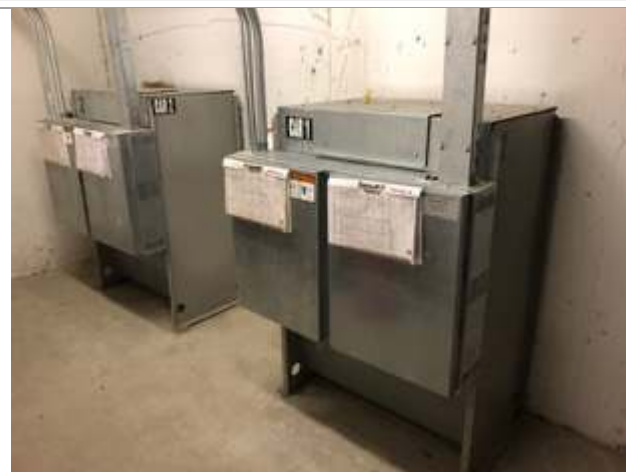
Photograph 107

Hydraulic operators

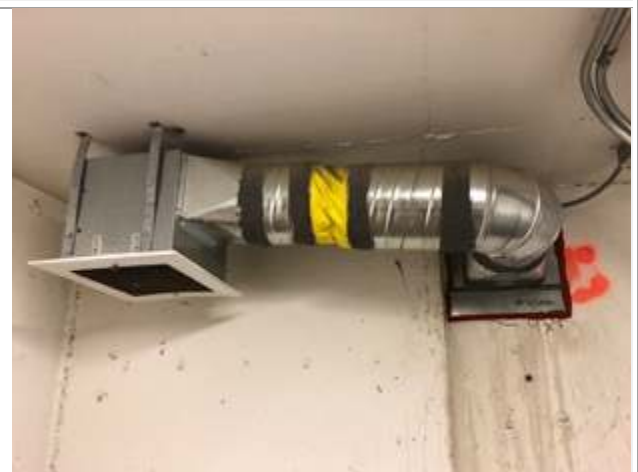
Photograph 108

Exhaust fan

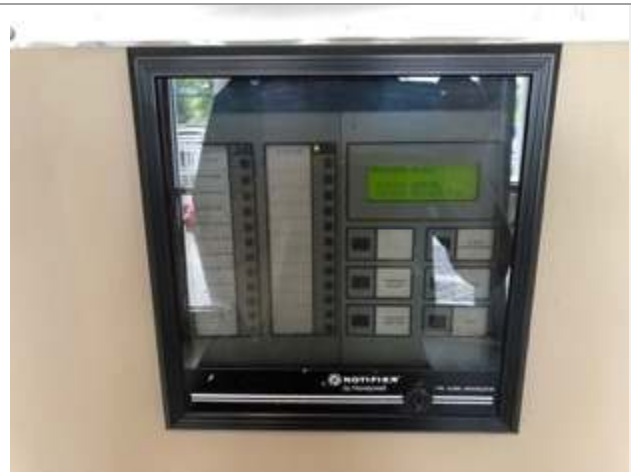
Photograph 112

Fire alarm remote annunciator

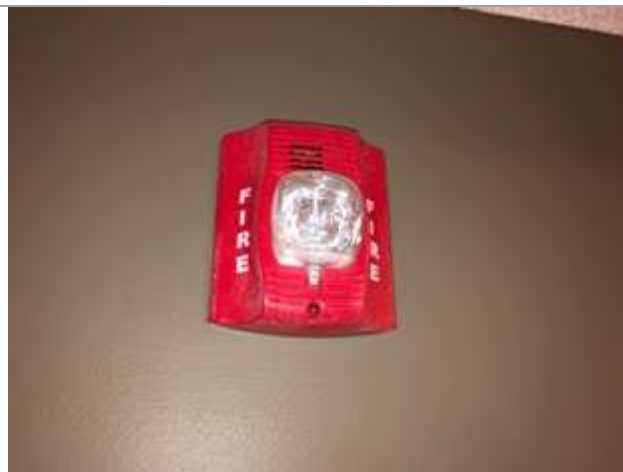
Photograph 113

Strobe alarm

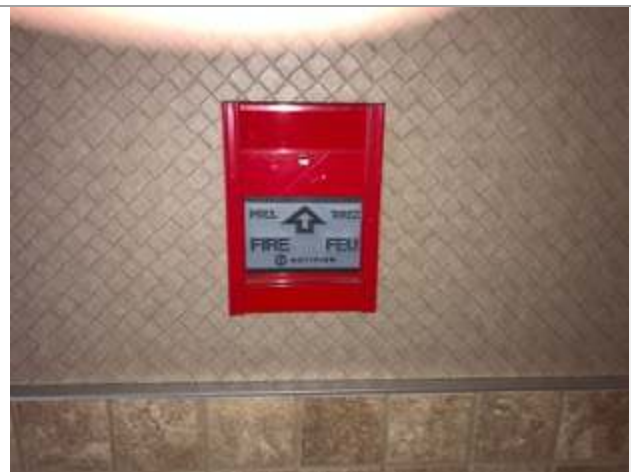
Photograph 114

Pull Station

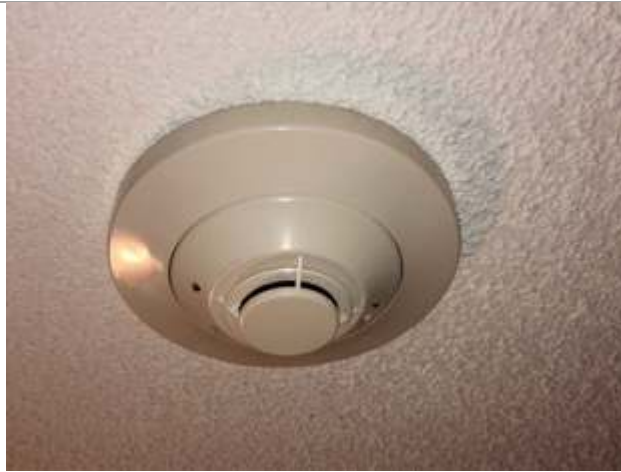
Photograph 115

Detector
