RESERVE FUND STUDY REPORT

**MACEWAN GARDENS II
CONDOMINIUM CORPORATION
263 MACEWAN ROAD, EDMONTON, AB
CONDOMINIUM PLAN No. 092 4818**

**DECEMBER 2019
REPORT AMENDED (AUGUST 2021)**

**WADE ENGINEERING LTD.**
15359-117 AVENUE, EDMONTON, AB T5M 3X4

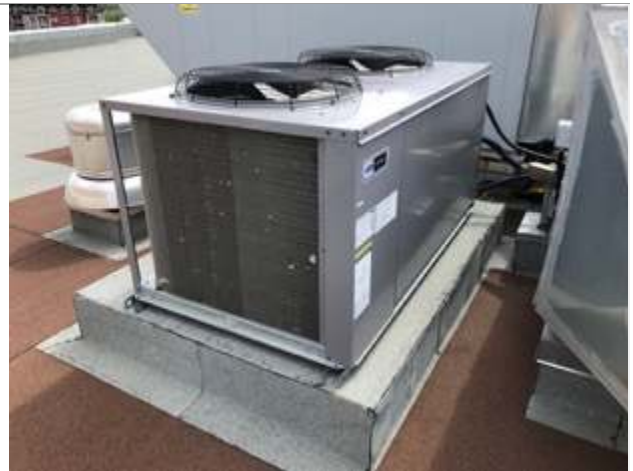
- No concerns were noted with the hallway make-up air system.
- Note: Replacement of rooftop mechanical unit(s) should be scheduled for replacement at the same time as the SBS roofing.*

Photograph 117
Condensing unit

- ❖ Schedule regular maintenance including replacement of air filters, refrigerant liquid line filter and cleaning of condenser and evaporator fins.
- ❖ Replace air filter in make-up air unit (MUA) quarterly or more often if required.

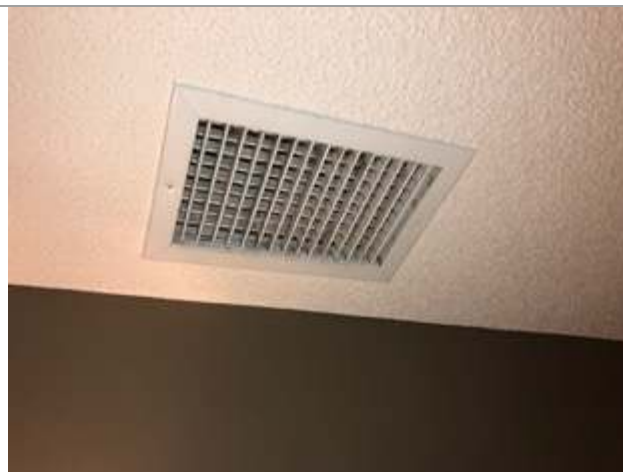
Photograph 118

Hallway grille

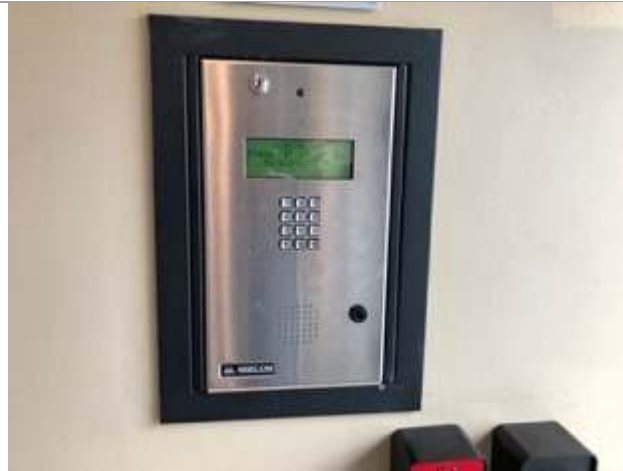
Photograph 119

Intercom

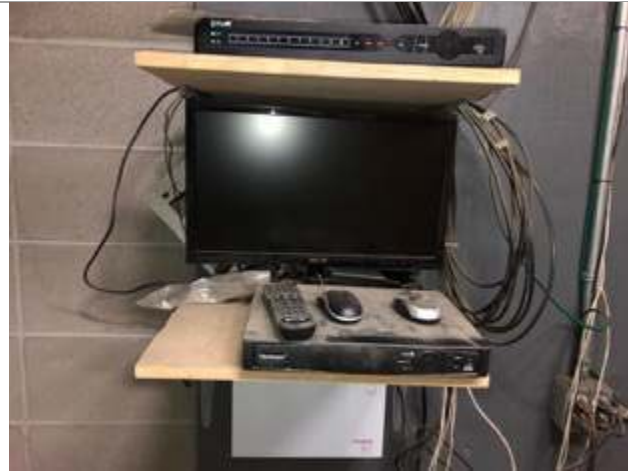
Photograph 120

CCTV system

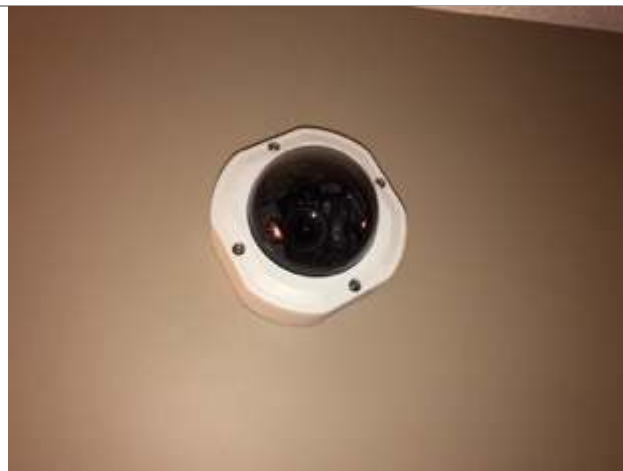
Photograph 121

CCTV camera

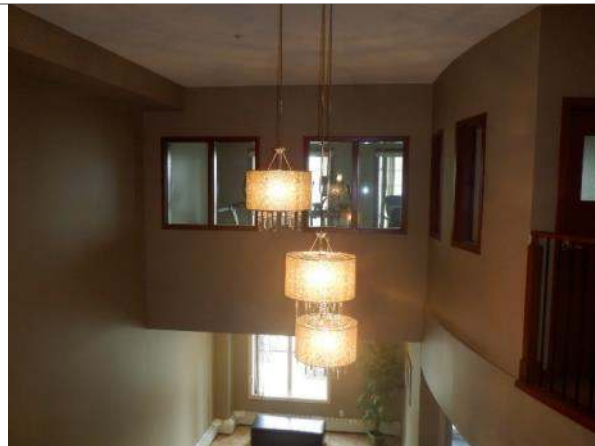
Photograph 122

Chandelier

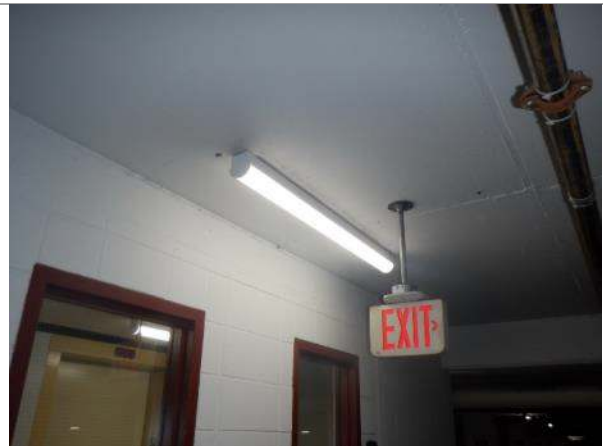
Photograph 123

Fluorescent lighting

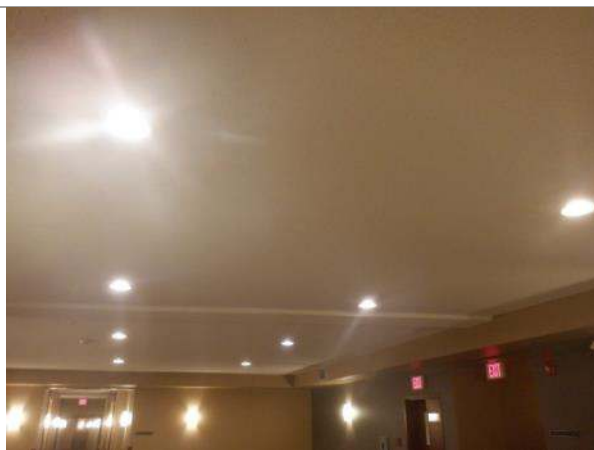
Wall and ceiling mounted lighting

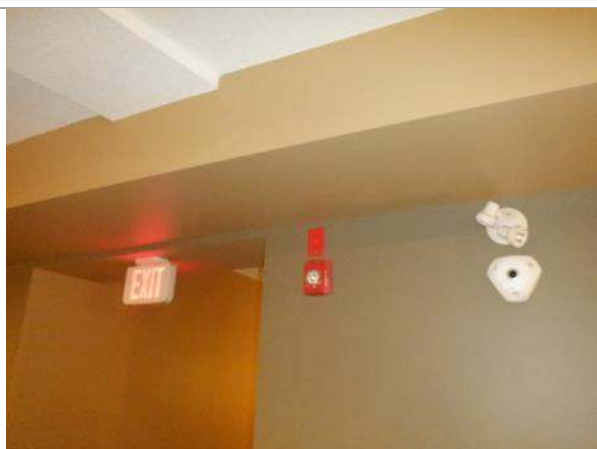
Photograph 126

Exit and emergency lighting

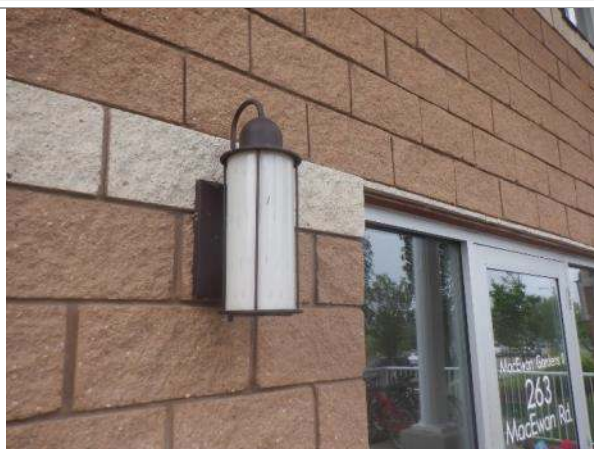
Photograph 127

Exterior wall mounted lights

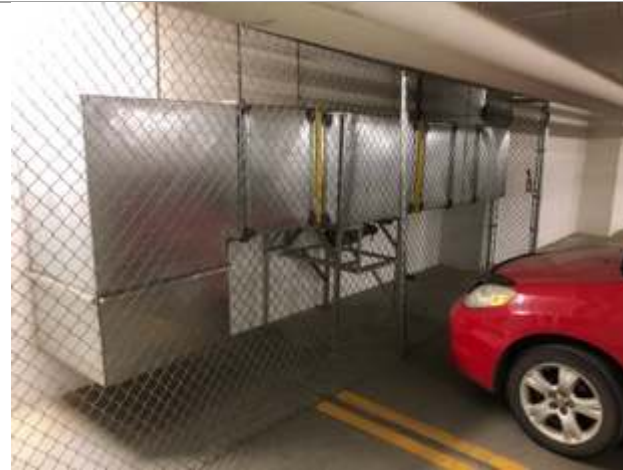
Photograph 130

- No concerns were noted with the parkade exhaust system.

Exhaust fan

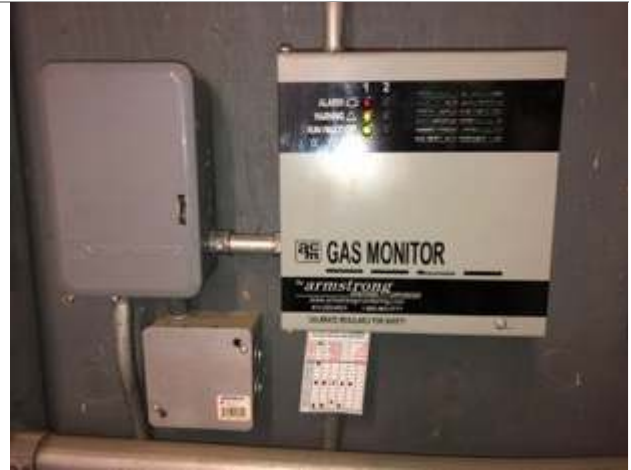
Photograph 131

Gas controller

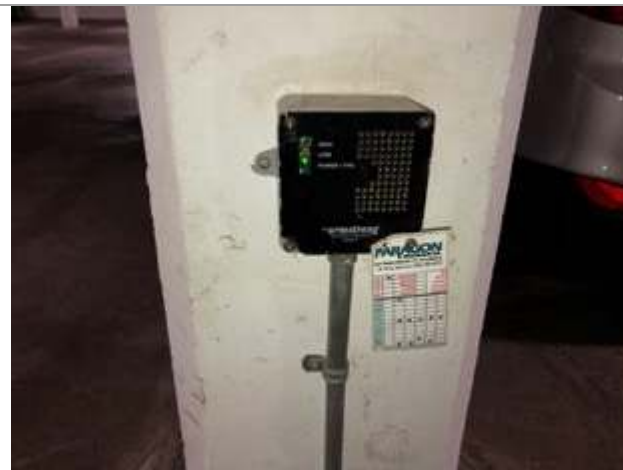
Photograph 132

Gas sensor

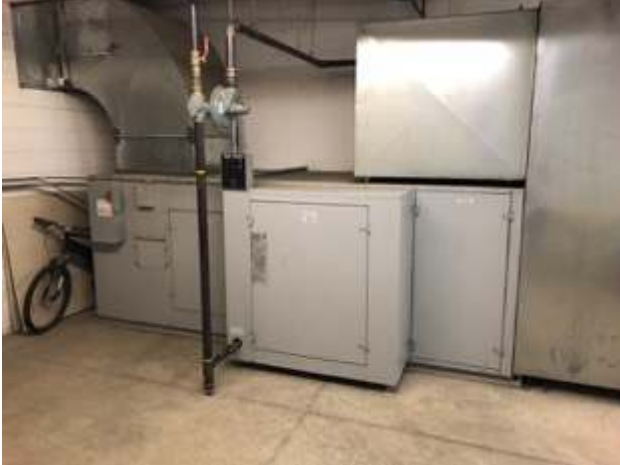
Photograph 133

<u>TYPE OF COMPONENT(S):</u> Parkade MUA system				<u>OVERALL CONDITION:</u> Good	
<u>CURRENT REPLACEMENT COST:</u>	<u>EXPECTED LIFE:</u>	<u>ACTUAL AGE:</u>	<u>EFFECTIVE AGE:</u>	<u>REMAINING LIFE:</u>	
\$52,500	35	11	11	24	
<u>COMPONENT DESCRIPTION:</u>					
<ul style="list-style-type: none"> - The building utilizes one (1) natural gas-fired parkade make-up air unit manufactured by Engineered Air; Model HE221 with 2,494,800 Btuh of heating capacity. This unit is interlocked with the parkade exhaust fans to provide fresh air make-up to the underground parkade when the exhaust fans are running. 					
<u>CONDITIONS NOTED:</u>					
<ul style="list-style-type: none"> - No concerns were noted with the parkade make-up air system.

<p>Make-Up air unit</p>		
<u>GOOD PRACTICE GUIDELINES:</u>					
<ul style="list-style-type: none"> ❖ Replace filter in make-up air unit (MUA) quarterly or more often if required. ❖ System should be checked at same time as the parkade exhaust system.

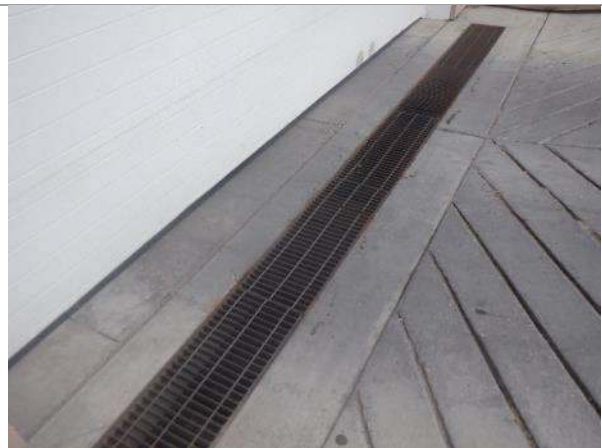
Photograph 135

Overview of poured concrete ramp with inslab heating and trench drain channel

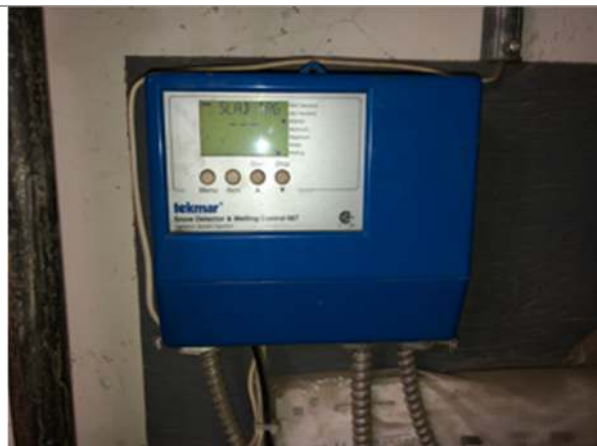
Photograph 136

Controller

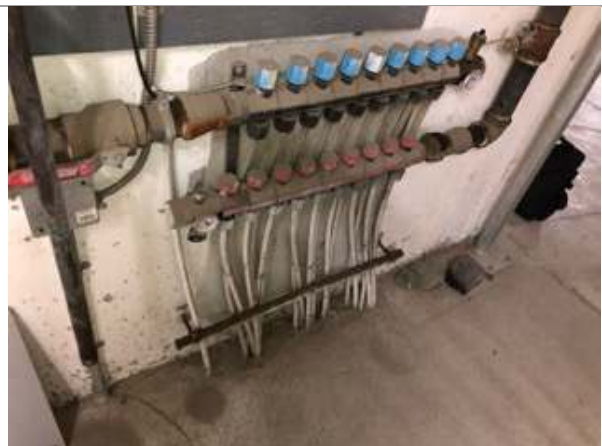
Photograph 137

Glycol loop piping

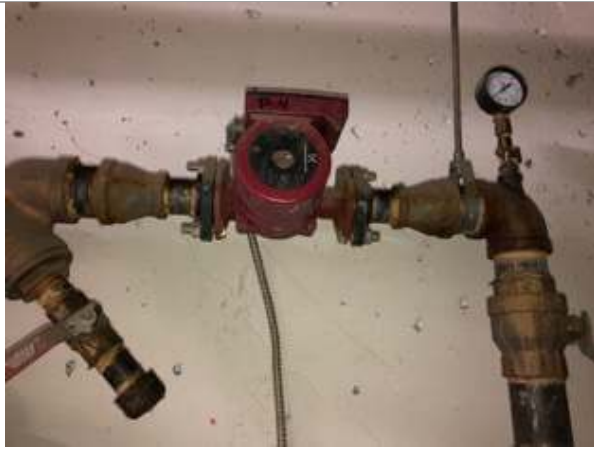
Photograph 138

Loop circulation pump

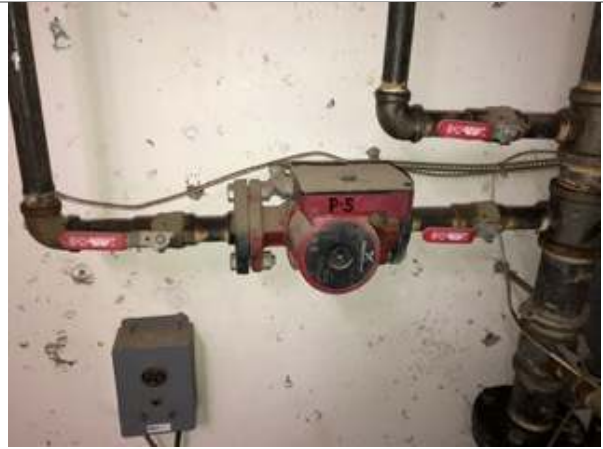
Photograph 139

Heat exchanger circulation pump

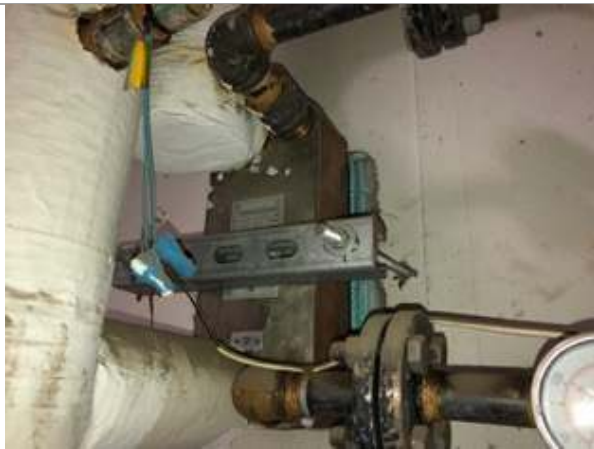
Photograph 140

Heat exchanger

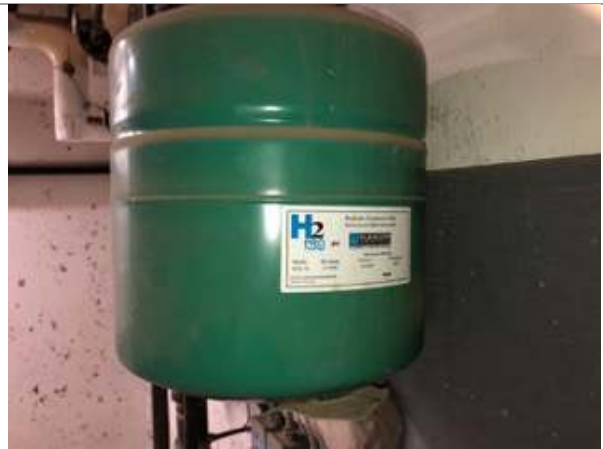
Photograph 141

Expansion tank

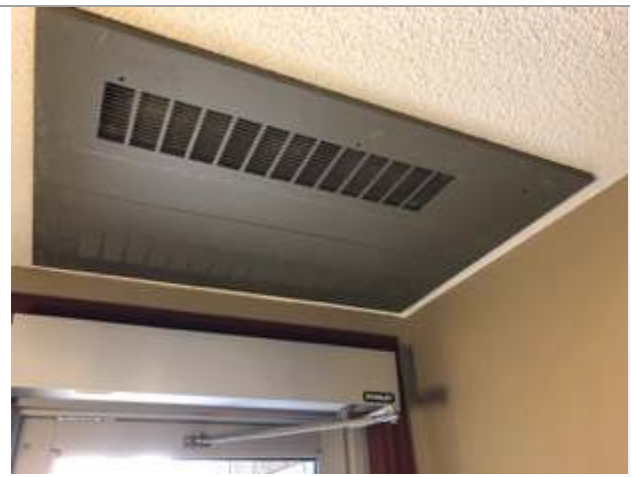
Photograph 143

Stairwell cabinet heater

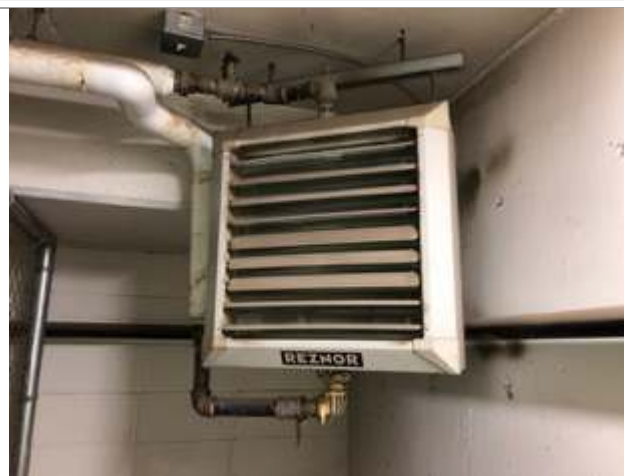
Photograph 144

Parkade unit heater

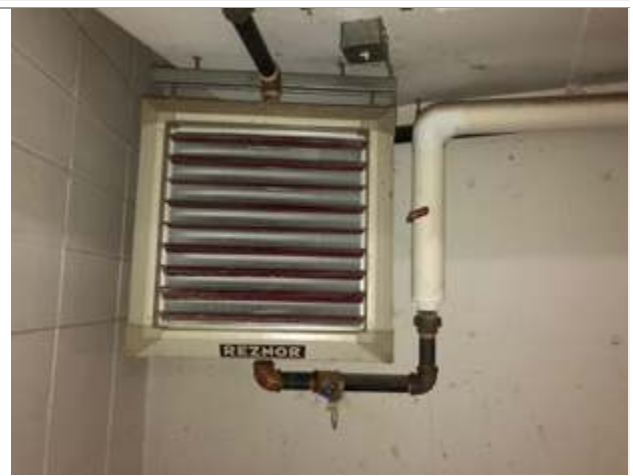
Photograph 145

Mechanical room unit heater

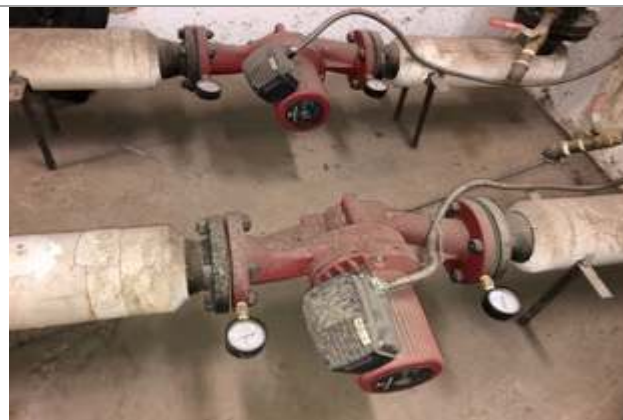
Photograph 146

Circulation pumps

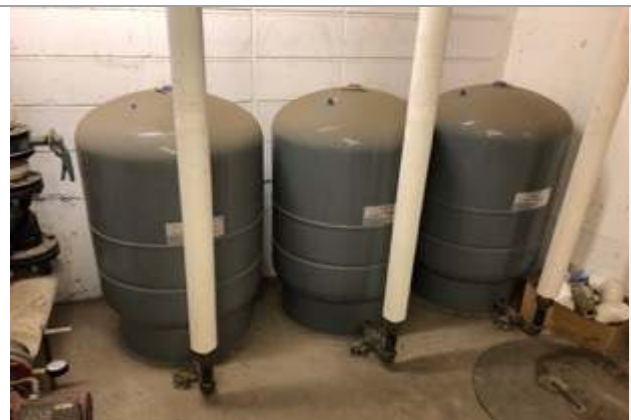
Photograph 147

Expansion tanks

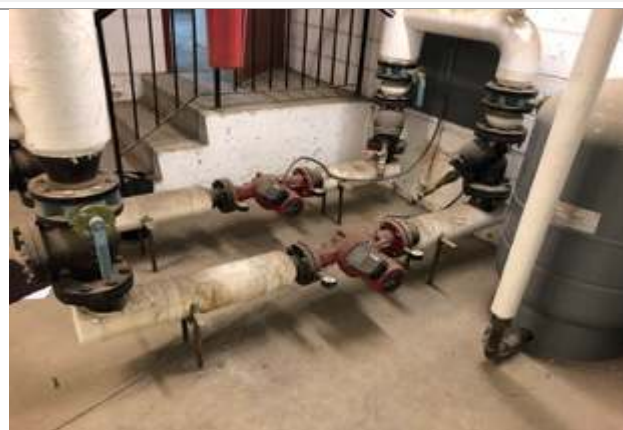
Photograph 148

Heating pumps

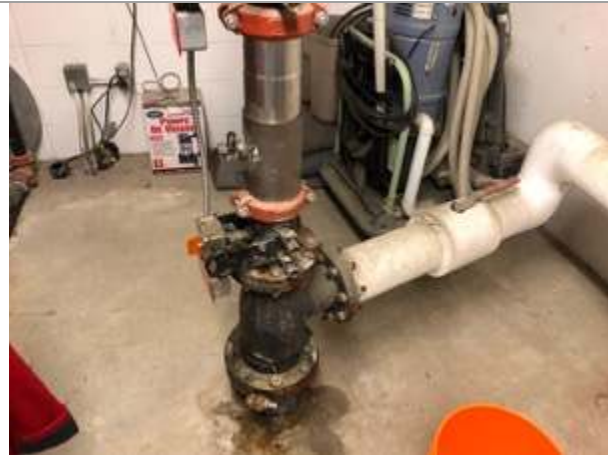
Photograph 149

Main building sprinkler service

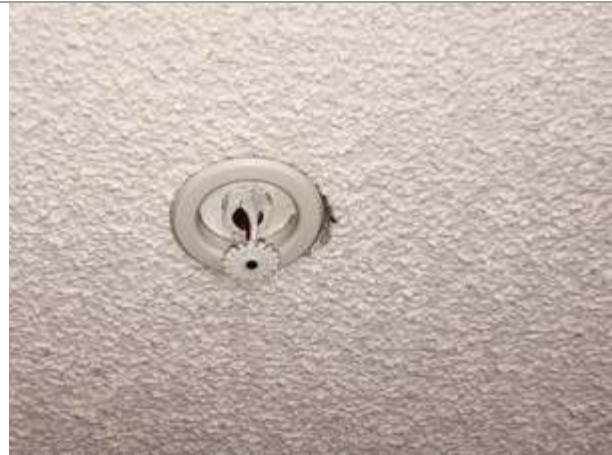
Photograph 150

Building sprinkler head

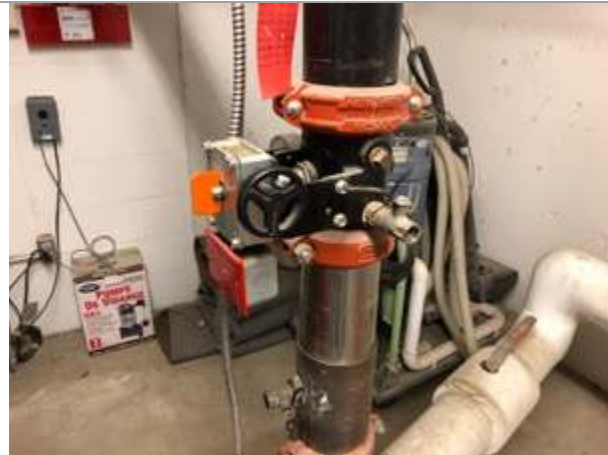
Photograph 151

Building DCVA

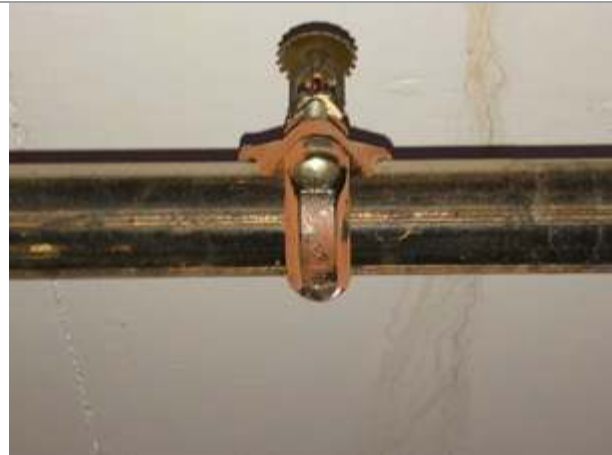
Photograph 152

Parkade sprinkler head

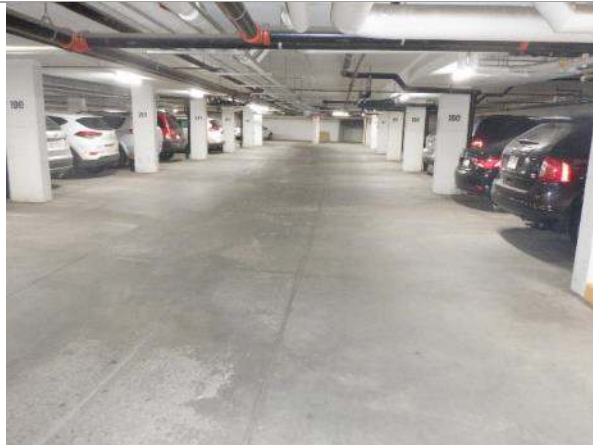
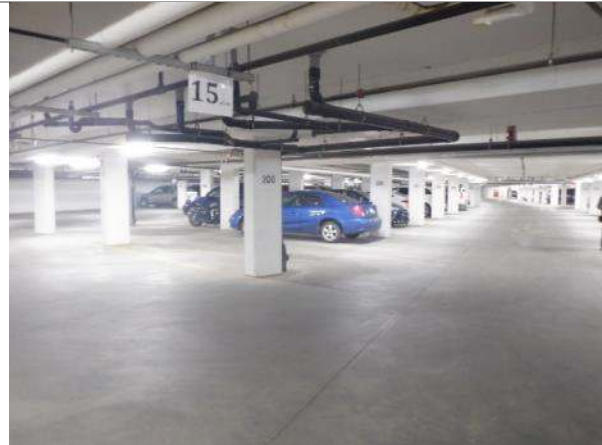
Overview of underground parkade

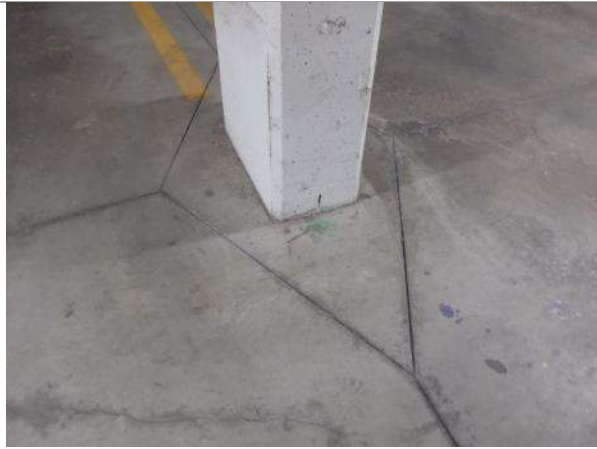
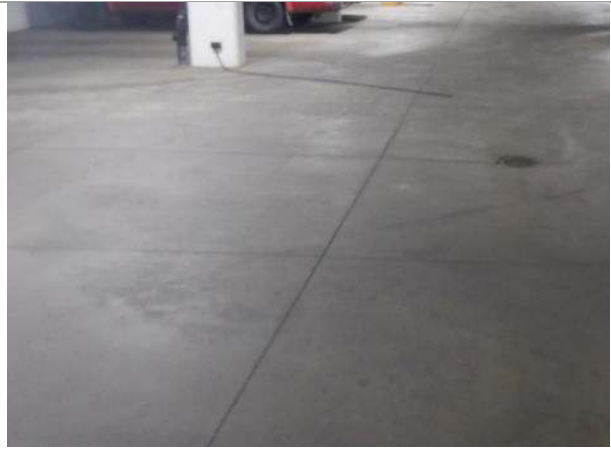
Diamond cut control joint around column and saw cuts on slab on grade concrete

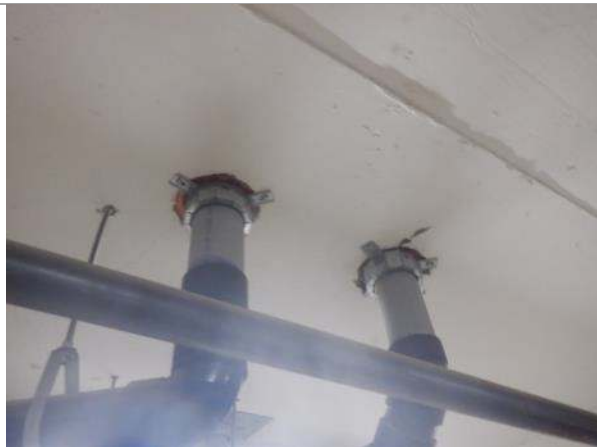
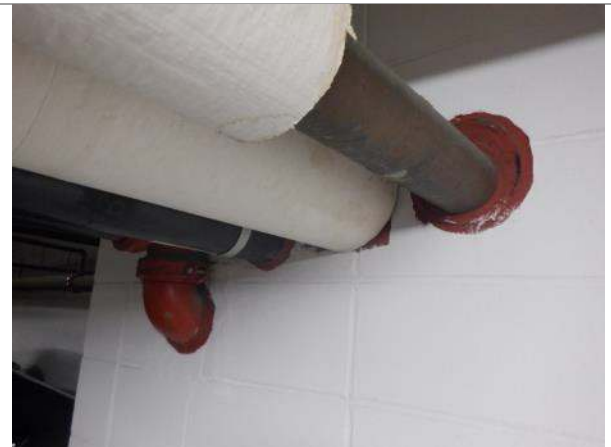
Fire stops at soffit and wall penetrations

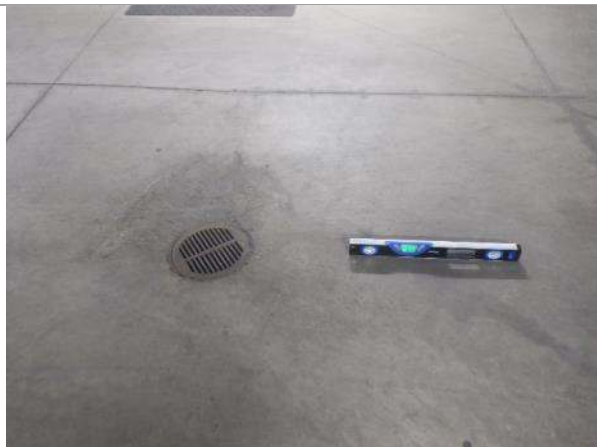
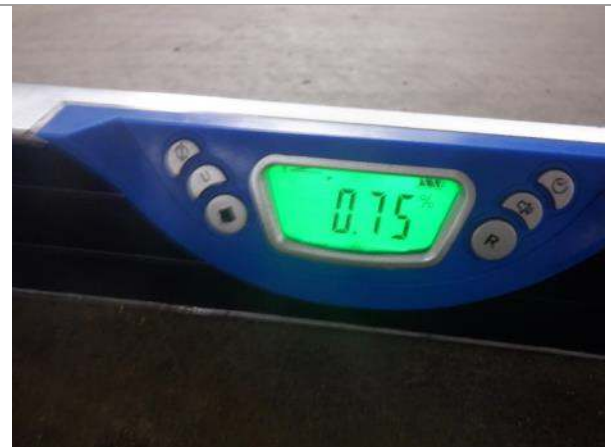
Slab on grade exhibiting positive slope towards parkade drain

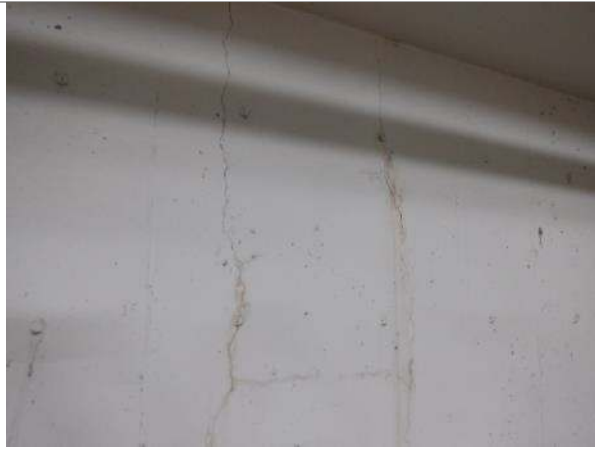
Photograph 179

- Diamond cut control joints around columns and saw cuts on slab on grade have been implemented to control cracking on the concrete slabs.
- Fire stops are installed in soffit penetrations.
- The slab-on-grade is positively sloped to drains throughout the parkade.
- Minor cracking and surface spalling was noted along heavy traffic areas on slab on grade.
- Minor cracking (dry) was noted at few locations on parkade walls and soffit.

Cracking on parkade walls and soffit

Note: No monies have been carried for the parkade as this is a life item; repairs will, however, be required from time to time and should be budgeted as necessary.

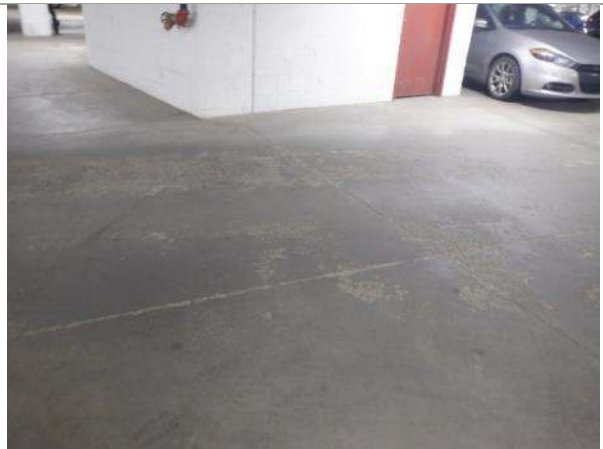
Photograph 182

Minor cracking and spalling of slab on grade concrete

- ❖ Inspect parkade regularly for water entry and schedule repairs or reviews as necessary.
